Summary of Lower Platte & Elkhorn Rivers

Initial Ice Report 12/20/2017 through 1/5/2018:

Ice Thickness Summary (1/4/2018)

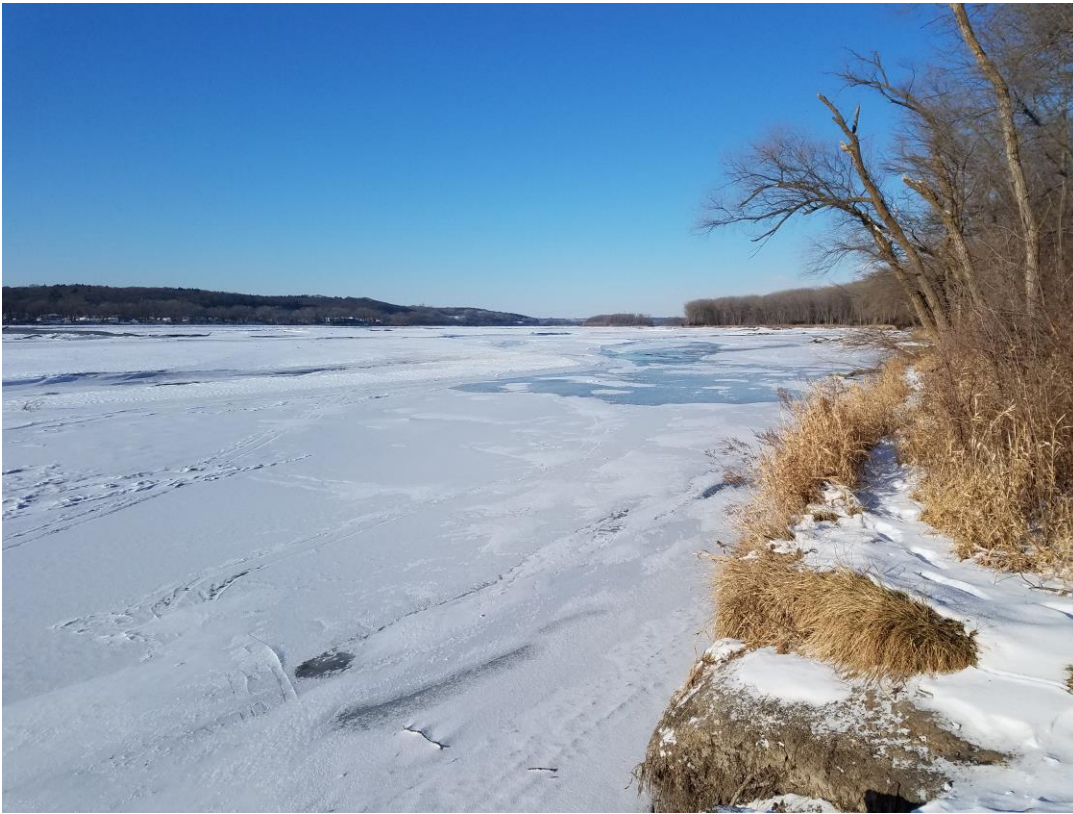
Near Hwy 31- Schram State Park Dec 28 2017

P7 - Sarpy County, on the Platte Hwy 31 at 204 St.

Latitude: 41:1:27 Longitude: 96:15:29 (Thursday, December 28, 2017 @ 10:01AM CDT)

Temperature was 17°F. The average wind speed was 5 mph (S). It was estimated that it was less than 4.3 feet bank full at this location. The channel remains 5%. It was noted: “The main channel flow route is noticeably changed from last year.”

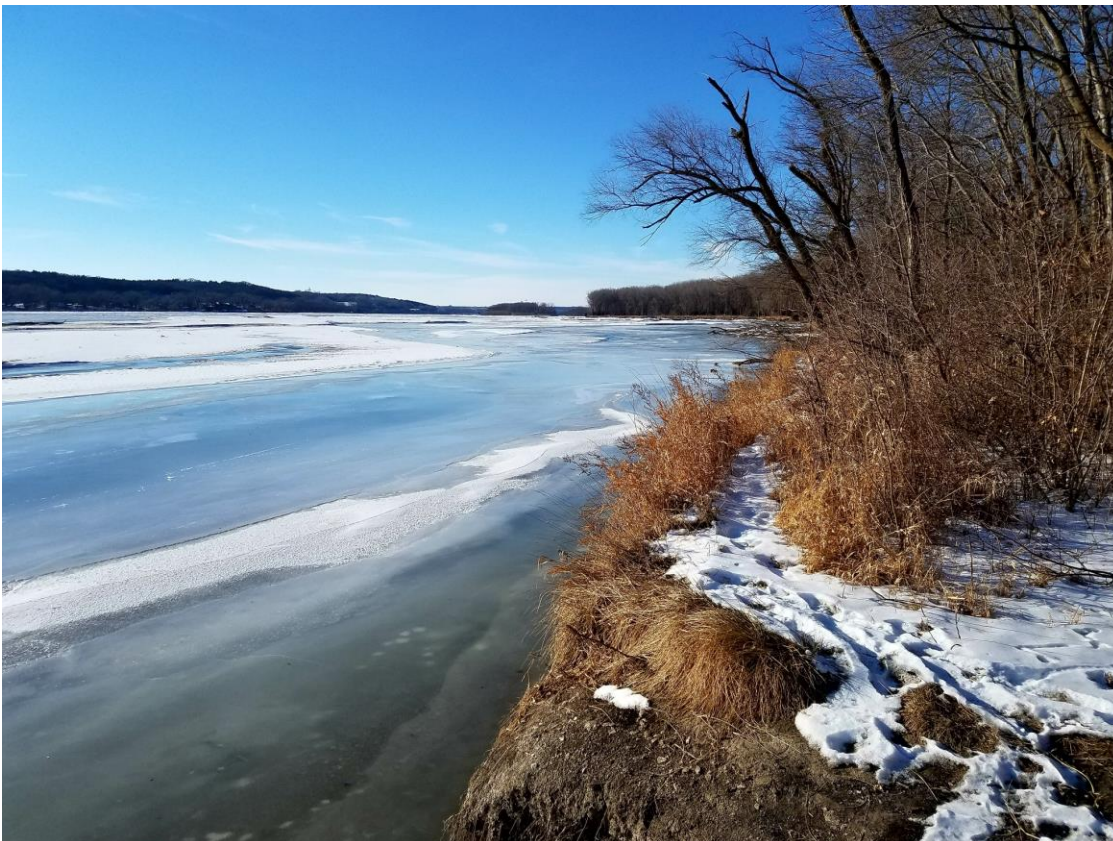
Schram State Park on Jan 3 2018

Latitude: 41:1:27 Longitude: 96:15:29 (Wednesday, January 3, 2018 @ 2:34PM CDT)

Temperature was 17°F. The average wind speed was 15 mph (NW). It was estimated that it was less than 2.7 feet bank full at this location. The channel remains 5%. It was noted: " Not much change from last week other than the ice thickness continues to develop with subzero temps in the area.”

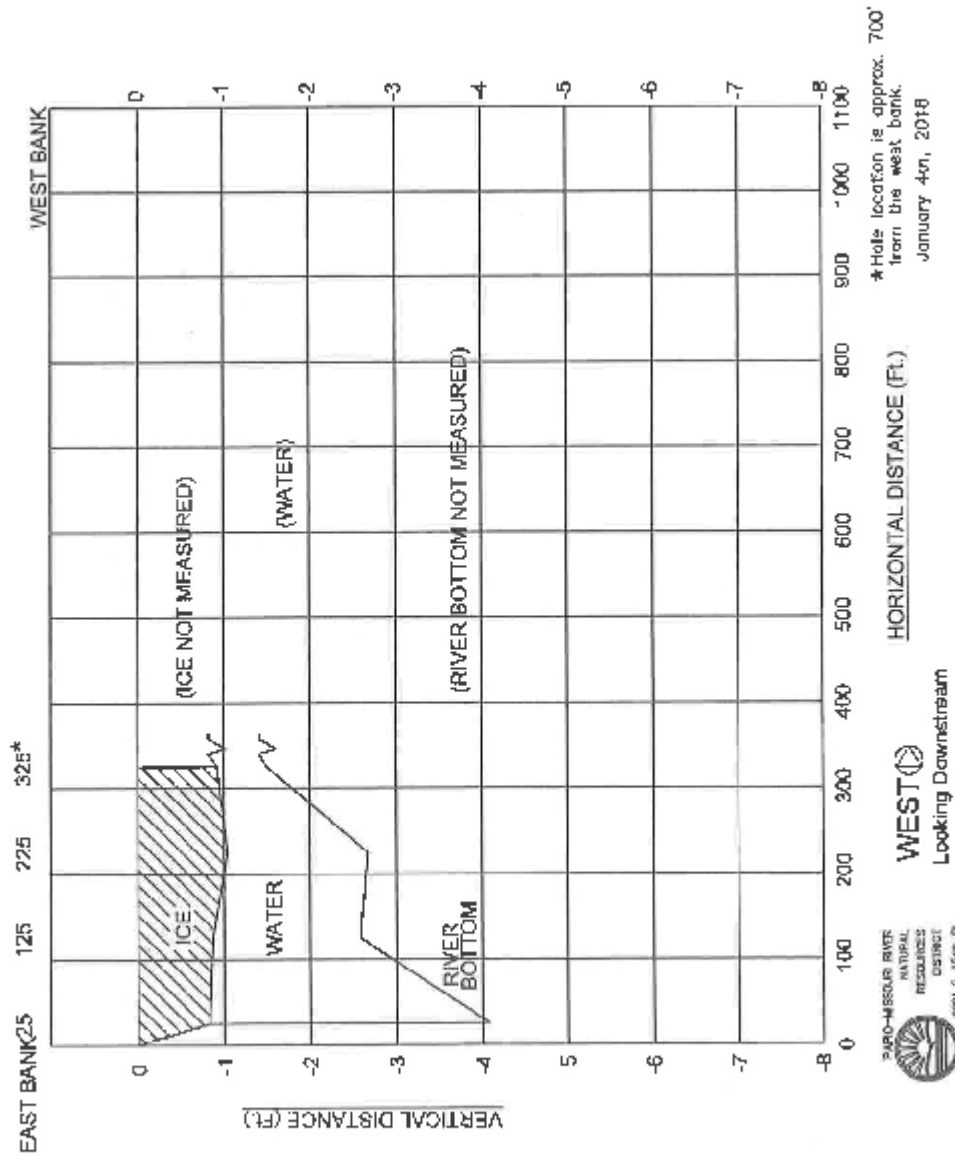
PLATTE RIVER: 1.1 Miles Upstream of Hwy. 64 (STA. 155+00, UNION DIKE)
(Werner Property)

On January 4, 2018, the writer performed ice thickness measurements on the Platte River. The measurements were taken perpendicular to the river flow, near the Union Dike on the Werner Property, at approximately Station 155+00 (1.1 miles upstream of Highway 64; location is known as 10 jetty site).

A gas-powered auger was used to drill the holes. The location of the holes on the table below were measured (stepped off) from the east bank of the Platte River. The snow cover on the ice varied from 2" to 3" in depth.

Distance From East Bank (Feet)	Ice Thickness (Inches)	Depth From Top Of Ice To River Bed (Inches)
25	10.0	49.0
125	10.5	26.5
225	12.5	32.0
* 325	11.0	18.0

*The entire river has an ice cover, but only the 0 to 325 ft. width of ice from the east bank of the river was considered safe enough to conduct borings. The west bank is approximately 700 feet west of 325 ft. boring.

The average ice thickness is **11.0 inches**.
