## *Summary of Lower Platte & Elkhorn Rivers*

### *Initial Ice Report 1/6/2018 through 1/13/2018:*

#### Ice Thickness Summary (1/13/2018)

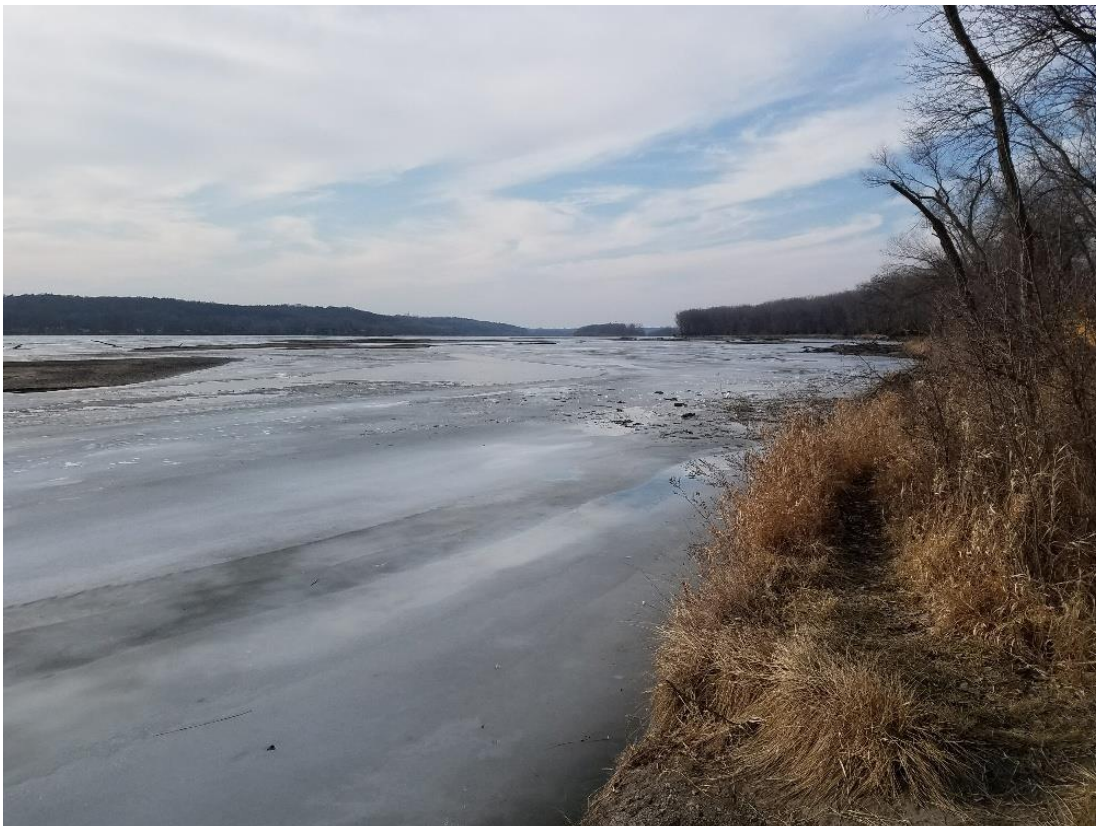
P7 - Sarpy County, on the Platte Hwy 31 at 204 St.

Temperature was 51°F. The average wind speed was 15 mph (S). It was estimated that it was less than 3.71 feet bank full at this location. The channel remains 20%. It was noted: "Ice conditions are at all stages of the life cycle to include isolated areas where breakup has occurred showing ice thicknesses of 6 to 8". " (Photo on Jan 10<sup>th</sup> 2018 –Lynn Marshall)

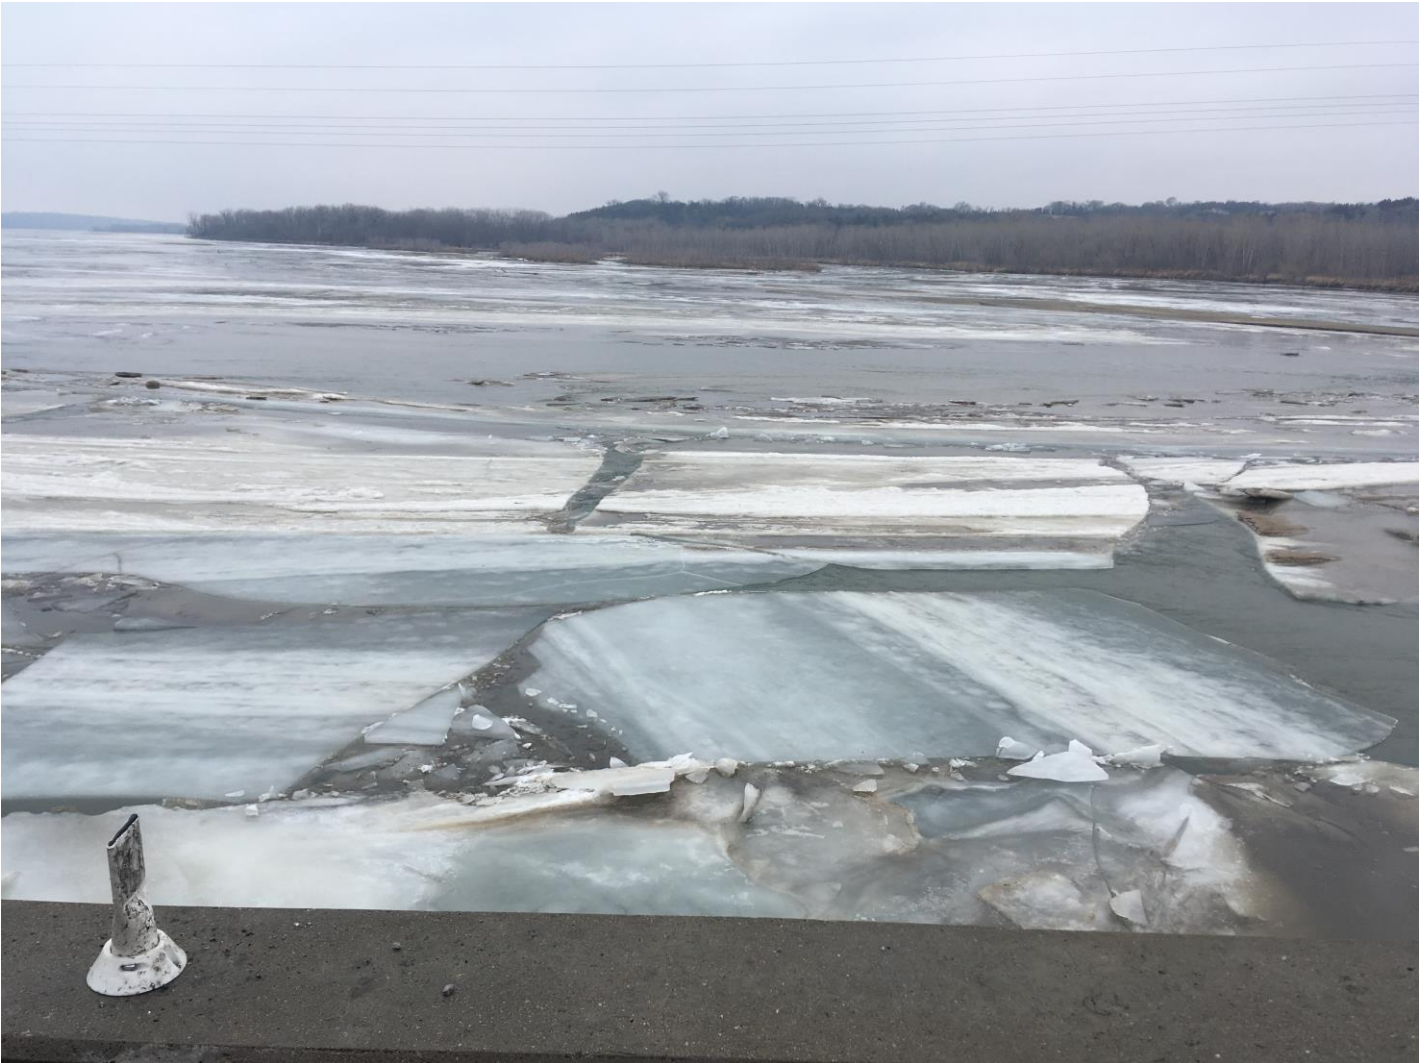
P10 - Sarpy County, on the Platte Hwy 50 & Platte River Bridge

Temperature was 30.2°F. The average wind speed was 15 mph (S). It was estimated that it was less than 3.71 feet bank full at this location. The channel remains NA%. It was noted: "Ice conditions are at all stages of the life cycle to include isolated areas where breakup has occurred showing ice thicknesses of 6 to 8". " (Photo Jan 10 2018 – Bryce Jensen)

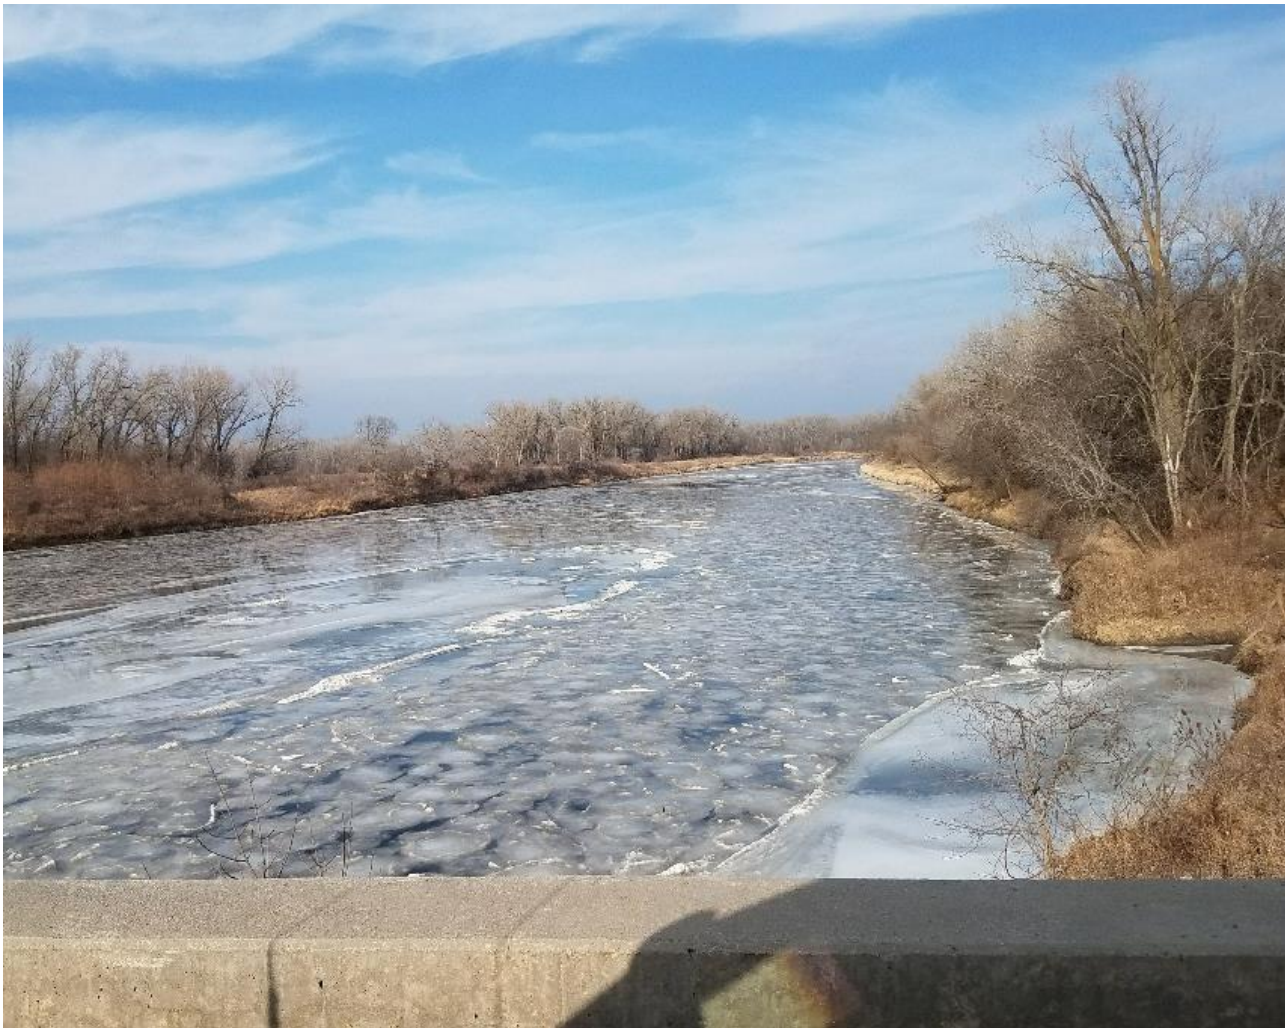
E1 - Sarpy County, on the Platte/Elkhorn Confluence of Platte and Elkhorn Rivers

Temperature was 37°F. The average wind speed was 10 mph (NW). It was estimated that it was less than 12 feet bank full at this location. The channel remains NA%. It was noted: " Melting snow on top of ice " (Photo below on Jan 10 2018 Lynn Marshall)
