Above the Flood: Elevating Your Floodprone House

FEMA 347/ May 2000

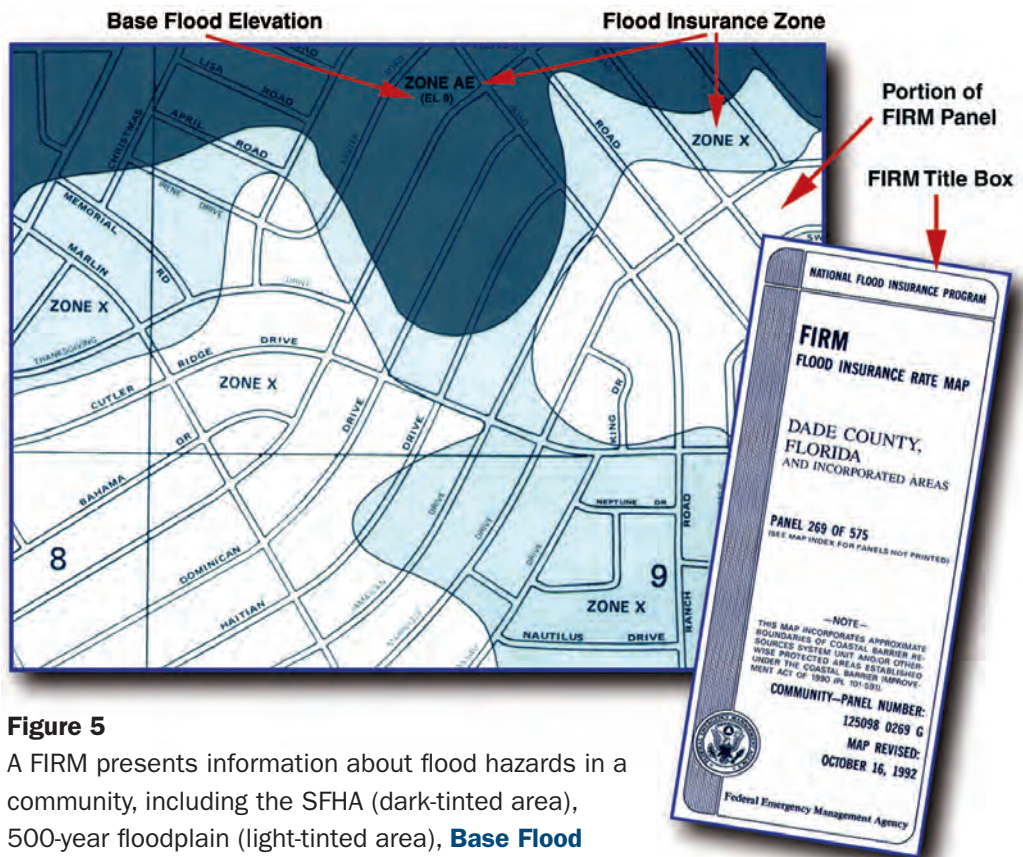
Figure 5 A FIRM presents information about flood hazards in a community, including the SFHA (dark-tinted area), 500-year floodplain (light-tinted area), **Base Flood Elevations**, (BFEs) (number in parentheses), and flood insurance zones (AE and X in this example).

Note that the SFHA in the example in Figure 5 is designated Zone AE. This zone is only one of several applied to SFHAs under the NFIP, including V, VE, V1-V30, A, AE, A1-A30, AO, and AH. These zones indicate differences in the types and severity of flood hazards in SFHAs. For the purposes of this publication, it is sufficient to focus on the basic differences between the two main types of SFHA zones—V zones and A zones. The distinction is important because regulatory requirements associated with V zones and A zones differ significantly. As explained later in this chapter, these requirements affect the types of building elevation techniques that may be used under the NFIP.

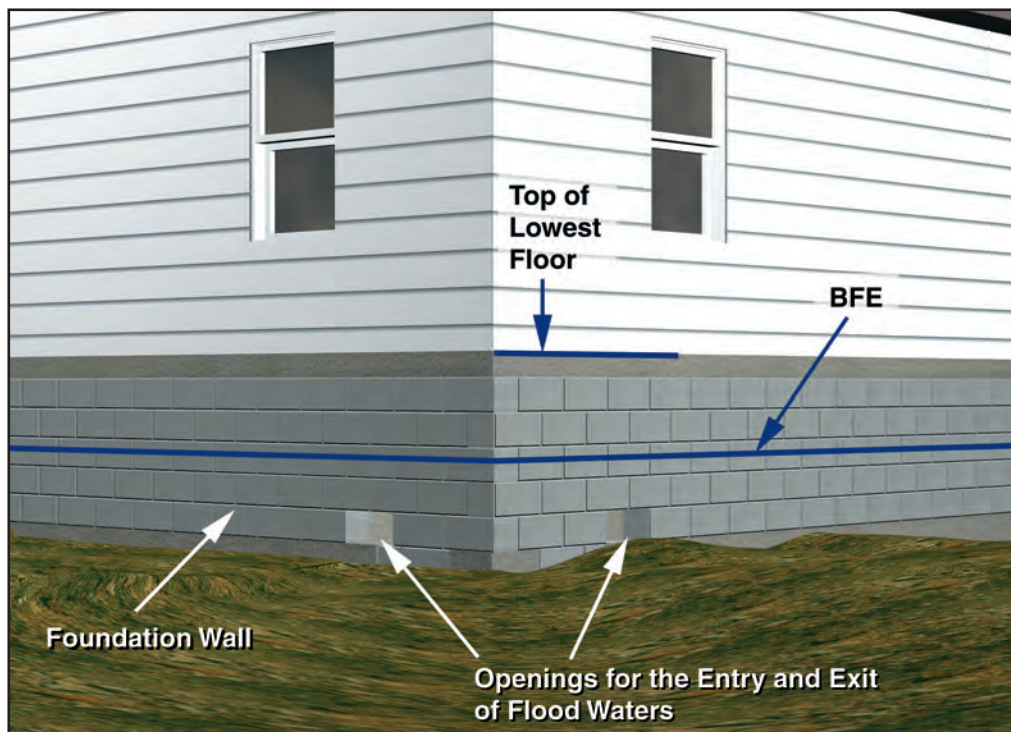
**Figure 6**

In a new, substantially improved, or substantially damaged building in an A zone, the elevation of the lowest floor must be at or above the BFE.

In A zones, where flood hazards are less severe, buildings may be elevated either on an open foundation or on continuous foundation walls below the BFE (Figure 6). Regardless of the type of foundation used, A-zone buildings must be elevated so that the **lowest floor** is at or above the BFE, as shown in Figure 6. If continuous walls are used below the BFE, they must be equipped with openings that allow flood waters to flow into and out of the area enclosed by the walls (Figure 6). Allowing the entry and exit of flood waters ensures that water pressures will be the same on both sides of the walls and reduces the likelihood that water pressure will cause the walls to fail.

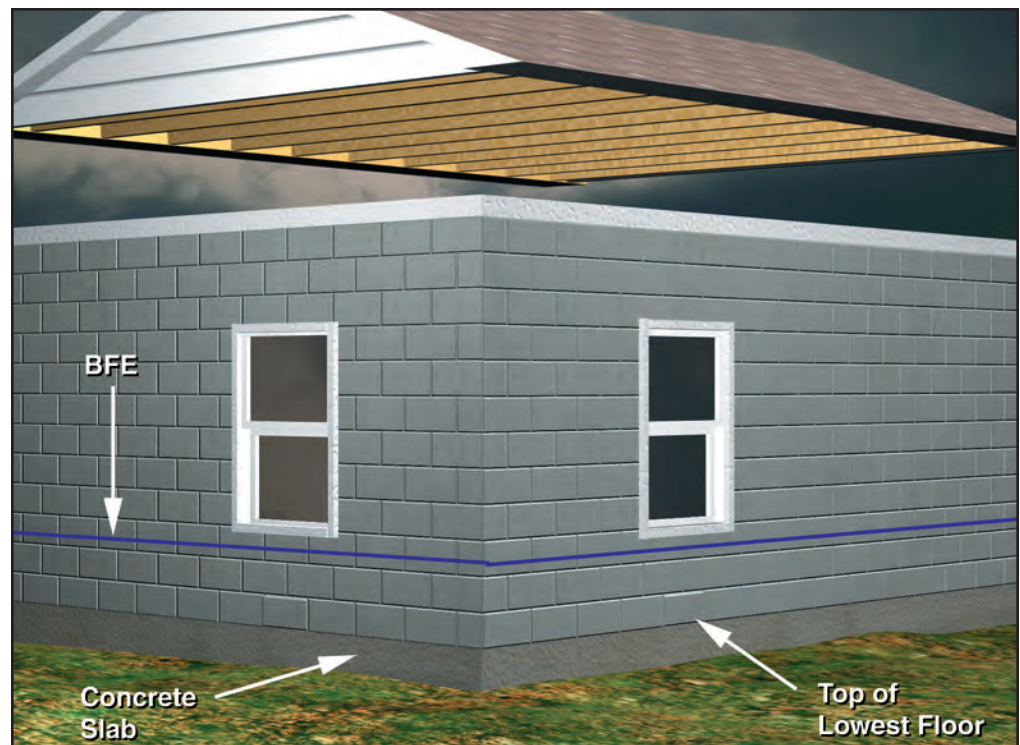
Figure 10
The first step in Technique 1 is removing the roof.

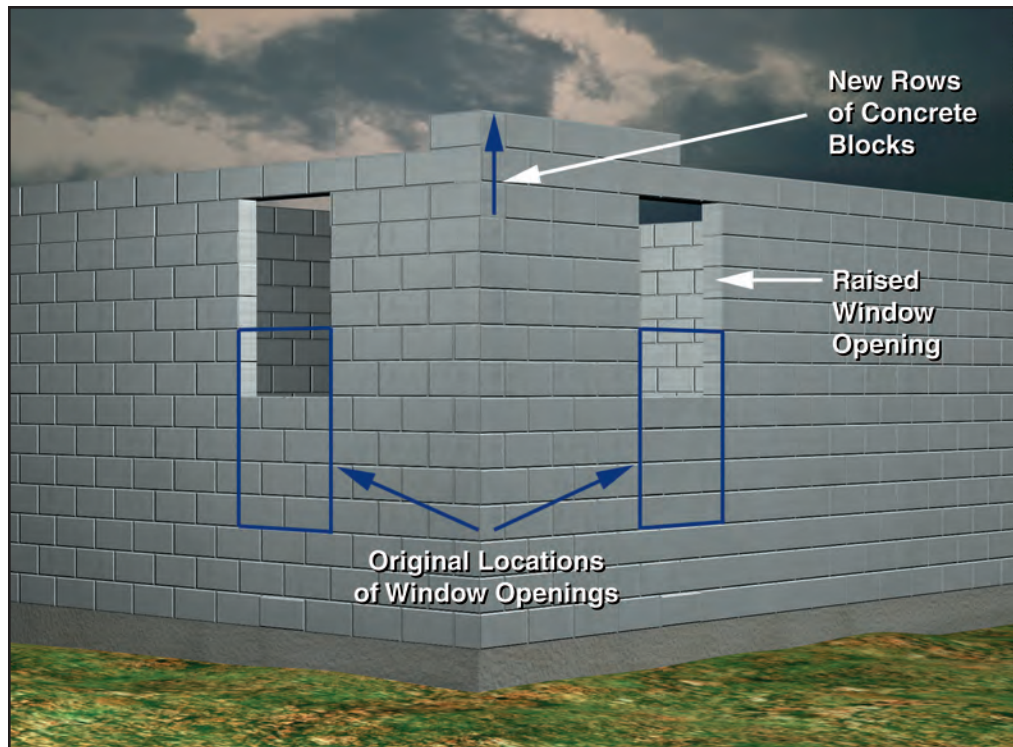
After the roof, windows, and doors are removed, several courses of concrete block are added to the tops of the existing walls and to the bottoms of the window openings (Figure 11). A corresponding number of blocks are removed from the tops of the window openings so that the size of the windows will remain the same. In addition, although not shown in Figure 11, concrete bond beams are formed in place at the tops of the extended walls to provide structural reinforcement.

The tops of the walls and bottoms of the window openings are raised with concrete blocks.

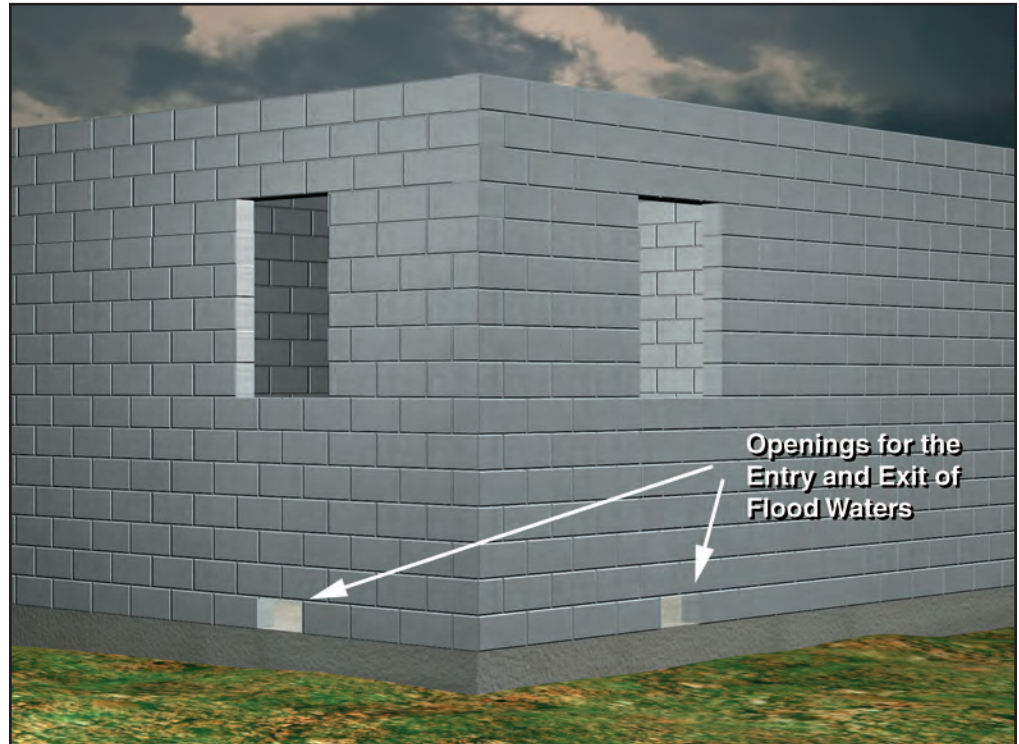
Figure 12
Openings are created in the walls near the ground.

Blocks are removed from the walls of the house at selected locations within 1 foot of the ground (Figure 12). The resulting openings will allow flood waters to flow into and out of the lower area of the house so that the water pressures on both sides of the walls will remain the same. The roof and windows are then replaced, and a new wood-frame floor is constructed above the flood level (Figure 13).

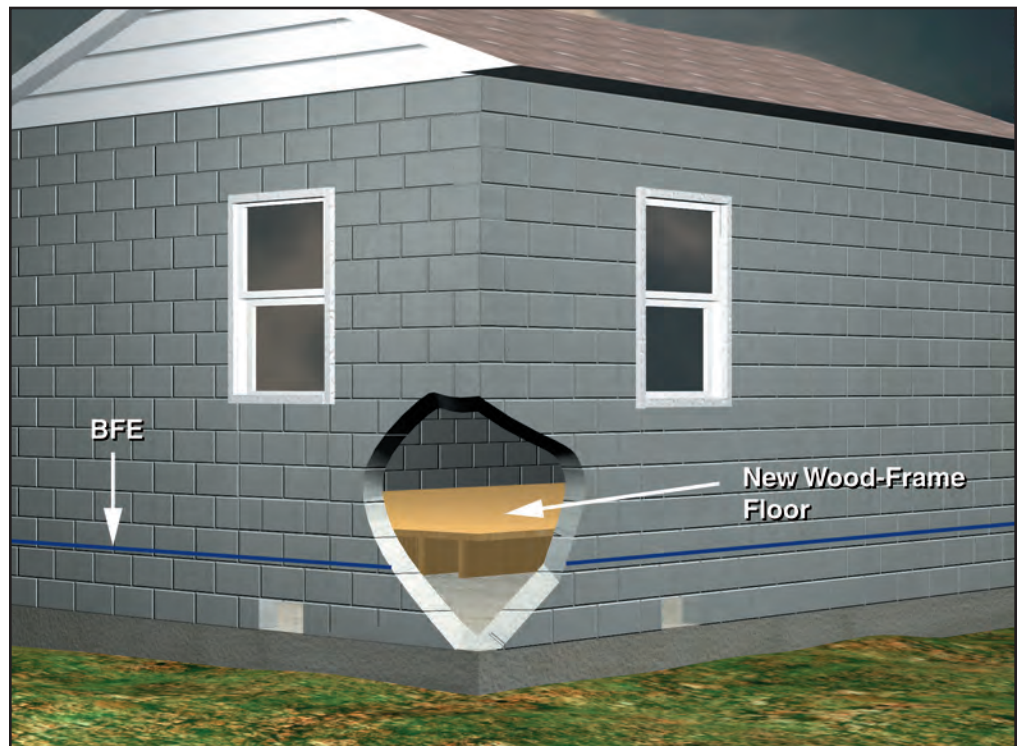
Figure 13
A new wood-frame lowest floor is constructed above the flood level, and the roof, windows, and doors are reinstalled.

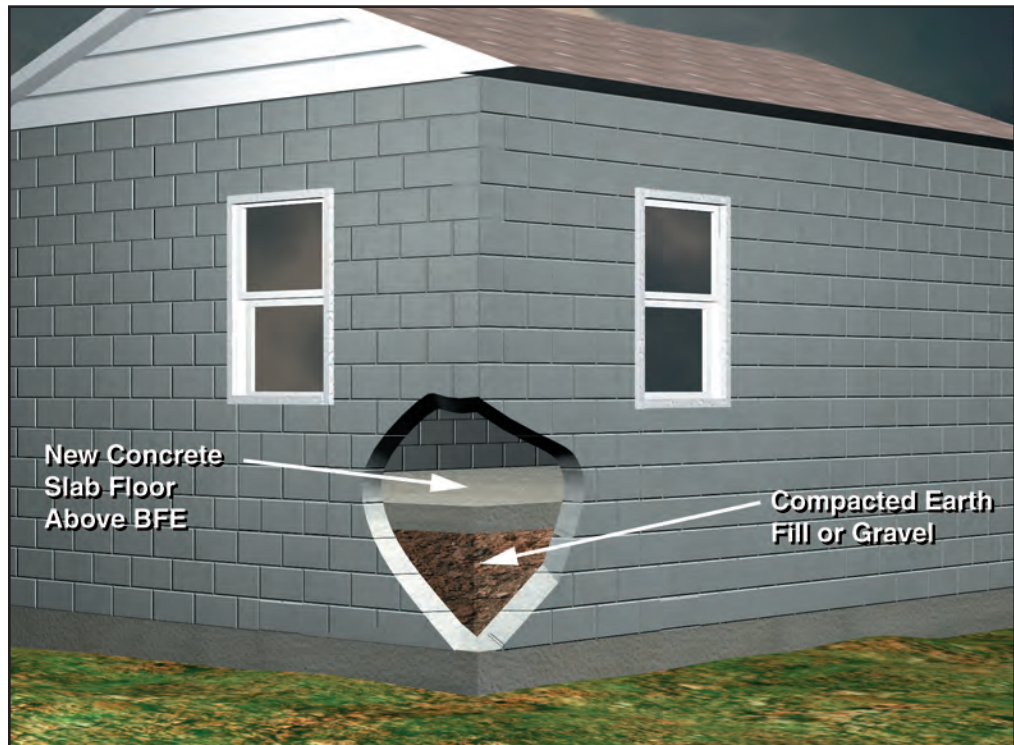
Figure 14
An alternative to building an elevated wood-frame floor is installing a new, elevated concrete slab floor on fill placed over the old slab.

A homeowner who chooses Technique 1 may decide to build a new concrete slab floor instead of a wood floor (Figure 14). When this option is chosen, compacted fill dirt or gravel is placed on top of the old slab and the new slab floor is poured on top. Because the area below the new floor is filled with dirt or gravel, wall openings are not required.

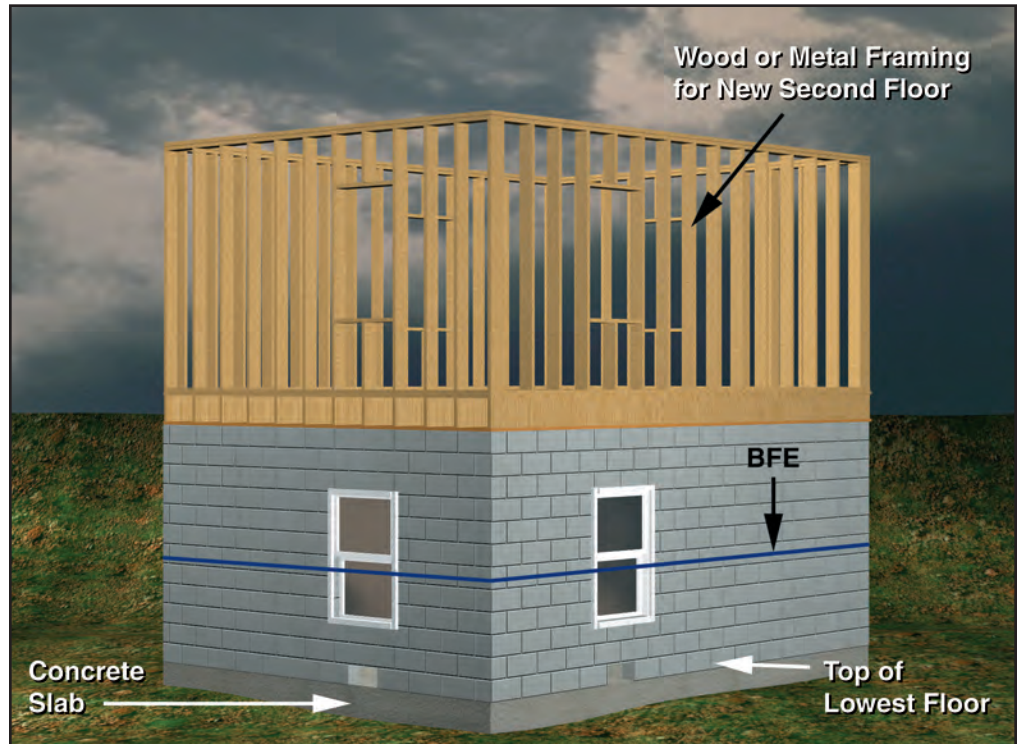
Figure 15
The new second-story floor and walls are built on top of the existing lower story.

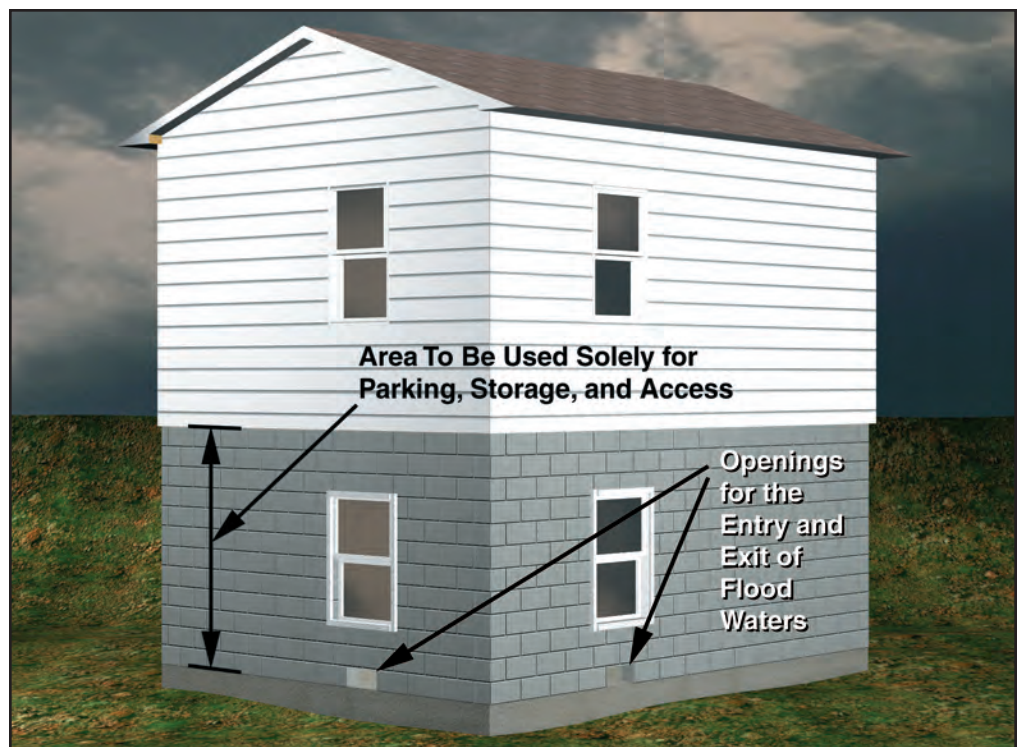
Figure 16
The new second-story walls are covered with siding or stucco.

Some homeowners prefer that the second story be constructed of masonry, but wood- or metal-framing is more common, primarily because it is lighter and less expensive. The roof is replaced, and blocks are removed from the walls to allow flood waters to enter and exit. Exterior sheathing is then added to the framed walls of the second story, the new windows are installed, and siding or stucco is applied to the sheathing (Figure 16).

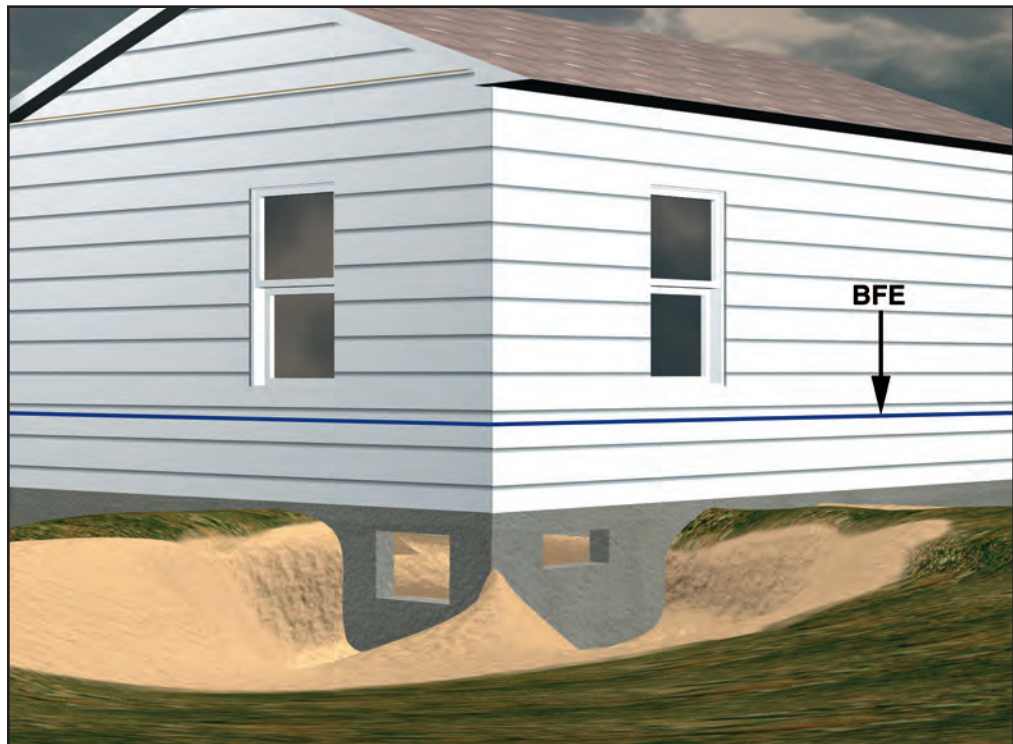
Figure 17
Trenches and tunnels under the slab provide access for the jacks and I-beams that will lift the house.

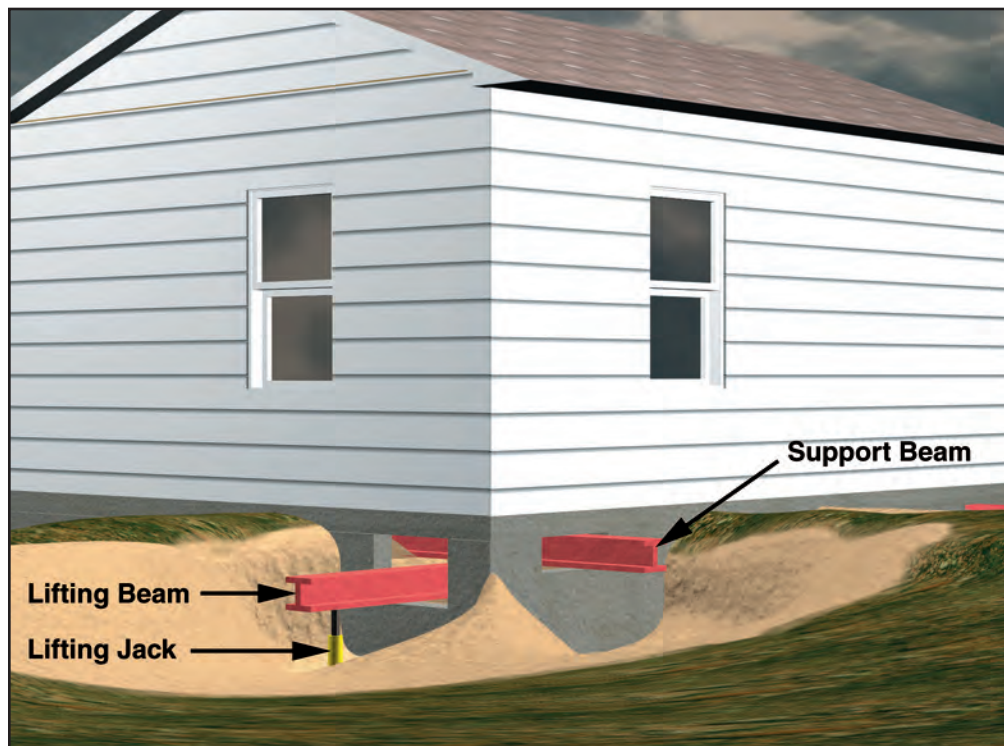
Figure 18
With I-beams and jacks in place, the house is ready to be lifted.

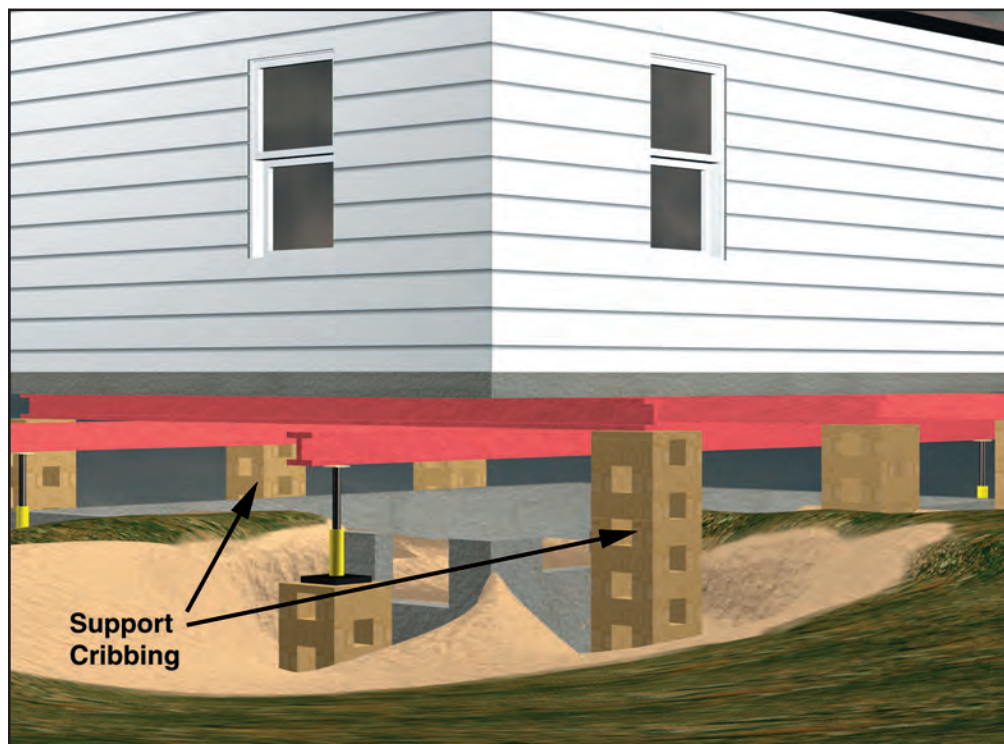
Figure 19
The house is temporarily supported on cribbing.

The house is then jacked up. When the jacks have extended as far as possible, the house must be supported temporarily while the jacks are raised. Both the house and the jacks are usually supported on “cribbing”—temporary piles of crisscrossed timbers (Figure 19). The jacks are then used to raise the house higher.

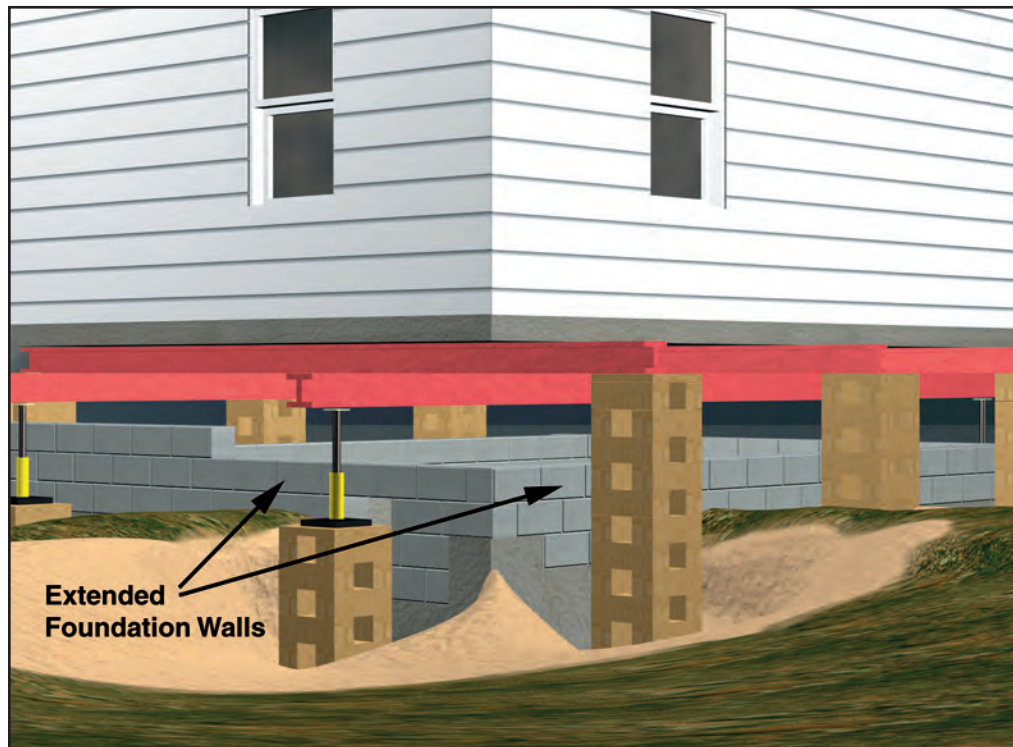
Figure 20
New, extended
foundation walls are
constructed with
concrete blocks.

This process is repeated until the house is raised to the desired height. The foundation walls are then extended upward with additional rows of concrete block (Figure 20). As in the previous techniques, openings are made in the walls within 1 foot of the ground so that flood waters will be able to flow into and out of the area below the elevated floor. The jacks and beams are removed, and the openings left around the beams are filled with blocks (Figure 21).

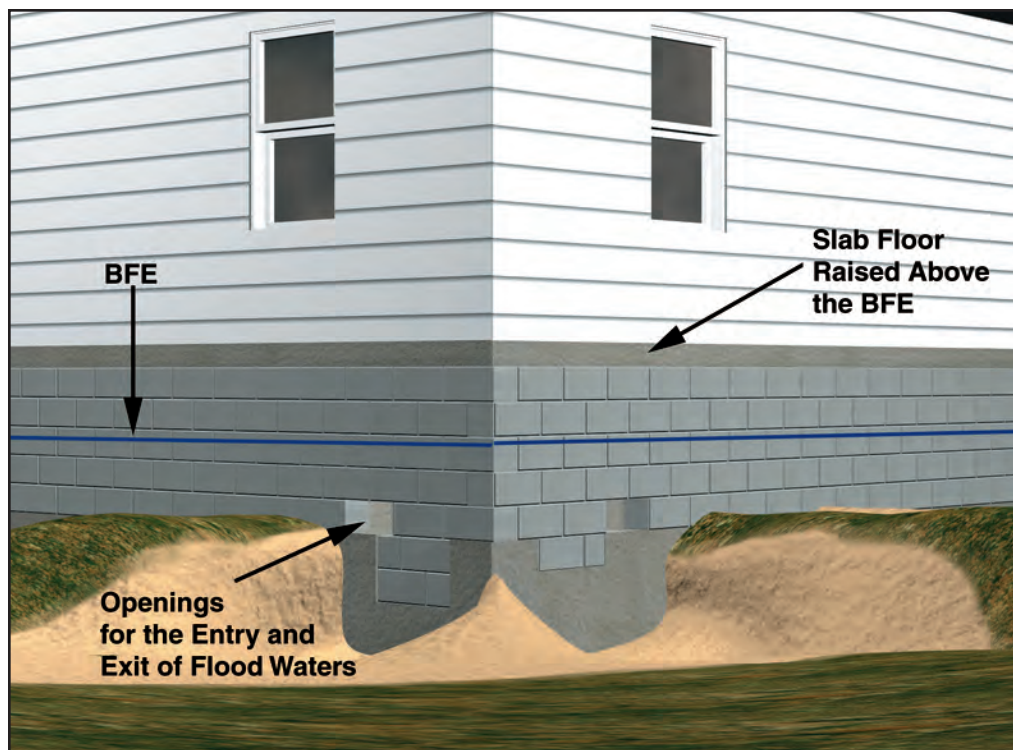
Figure 21
Elevated house and
slab on new, extended
foundation walls.

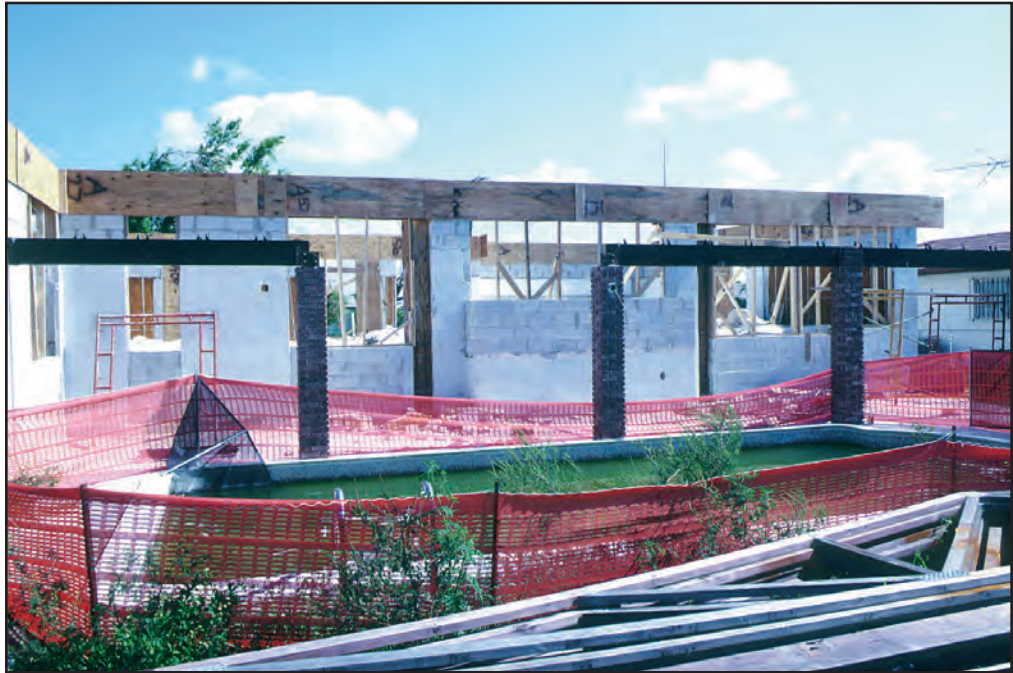
Figure 23
View from the back of the house. The walls have been extended upward with concrete blocks. The plywood visible at the tops of the walls is used to form cast-in-place concrete bond beams that will strengthen the extended walls. The roof trusses shown in the foreground were salvaged for reinstallation. The owner of this house decided to replace the original roof sheathing and shingles with new materials.

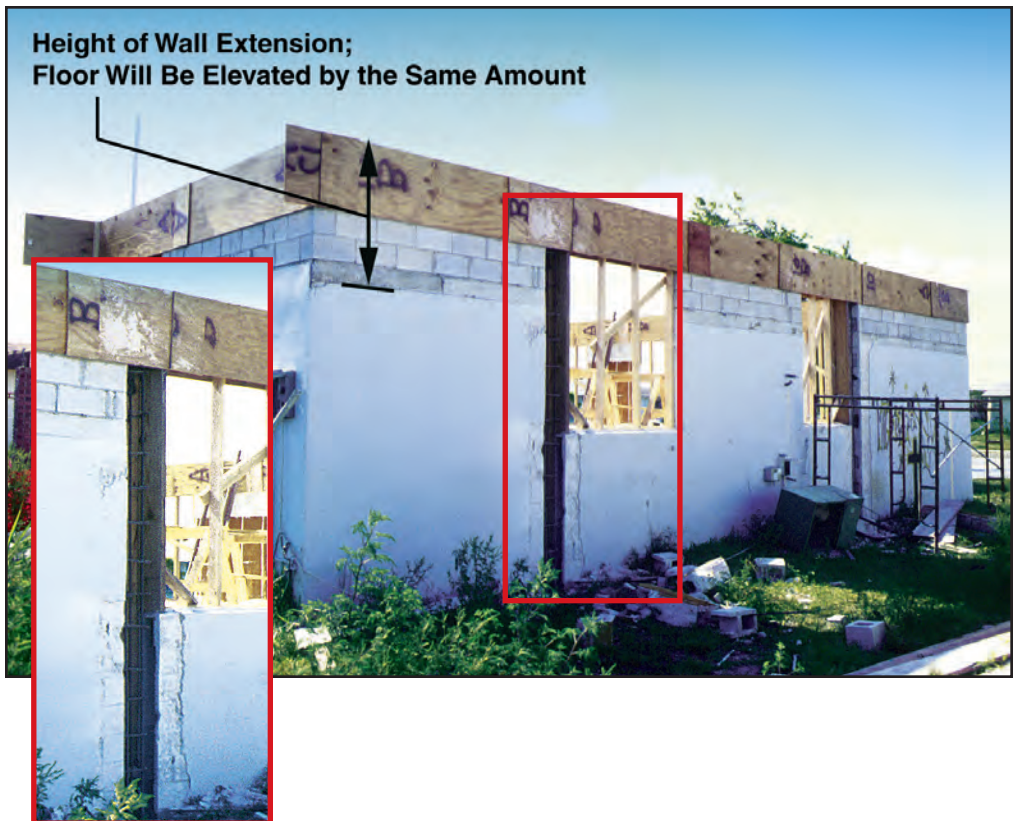
Figure 24
Another view of the extended walls. The vertical cuts in the walls next to the windows are for concrete tiedown columns that will be cast in place to further strengthen the extended walls against wind loads. The owner of this house was able to meet the elevation requirement by raising the floor only a few feet, as indicated by the amount that the walls have been extended.

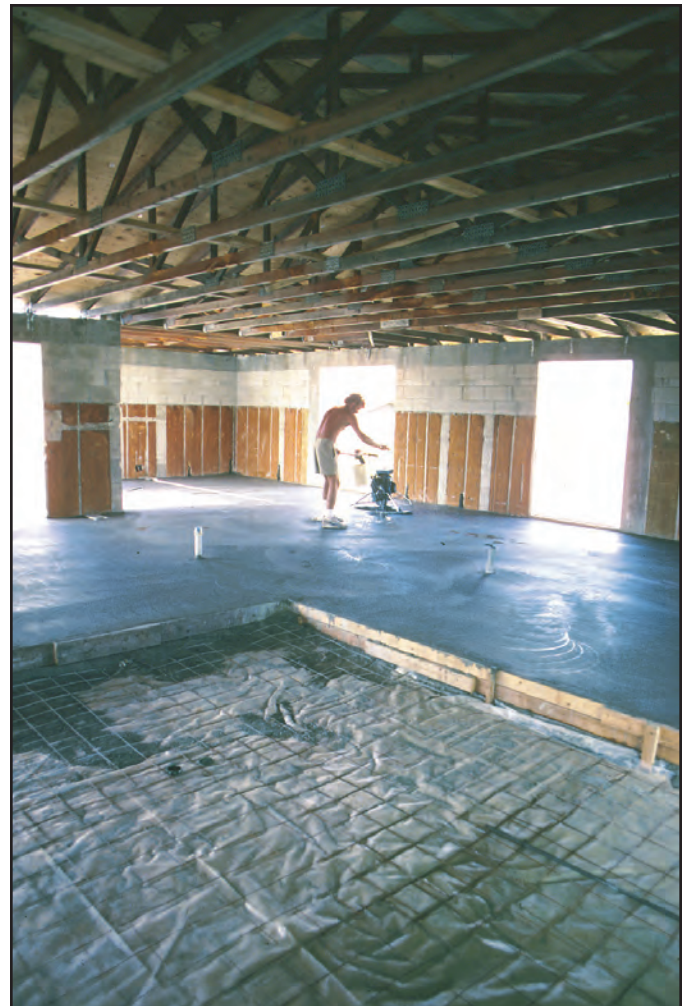
**Figure 26**

The roof has been rebuilt with the salvaged trusses, and most of the new concrete slab has been poured on top of the sand fill. The open area in the foreground, where plastic sheeting and wire reinforcement can be seen on top of the sand fill, is where the remaining part of the slab will be poured.

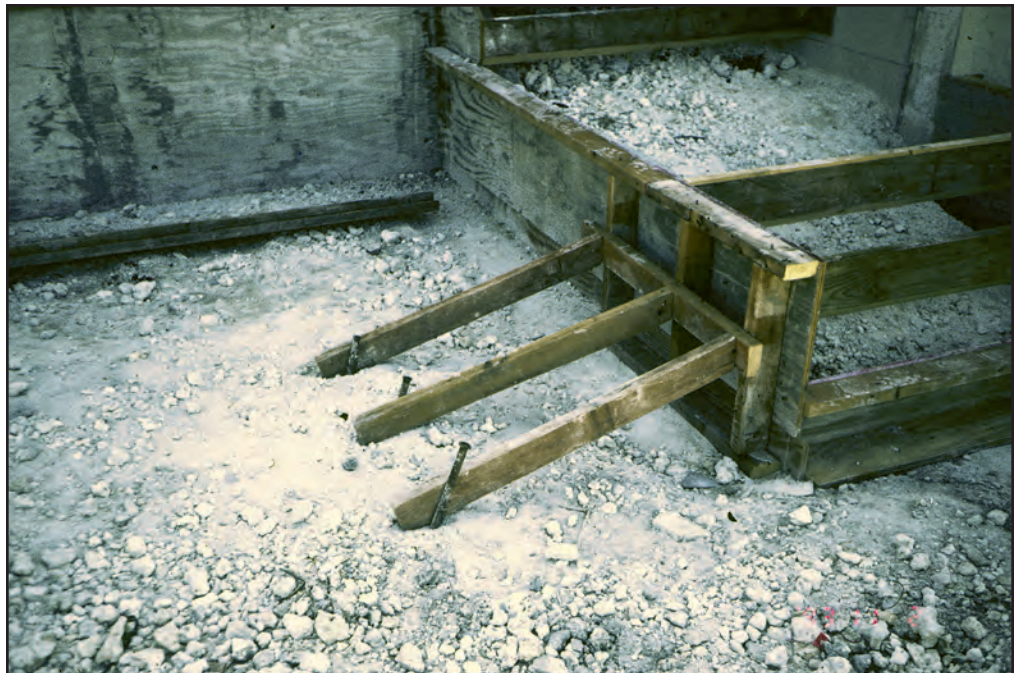
Figure 33
Wood framing for a new concrete staircase that will provide access to the elevated floor.

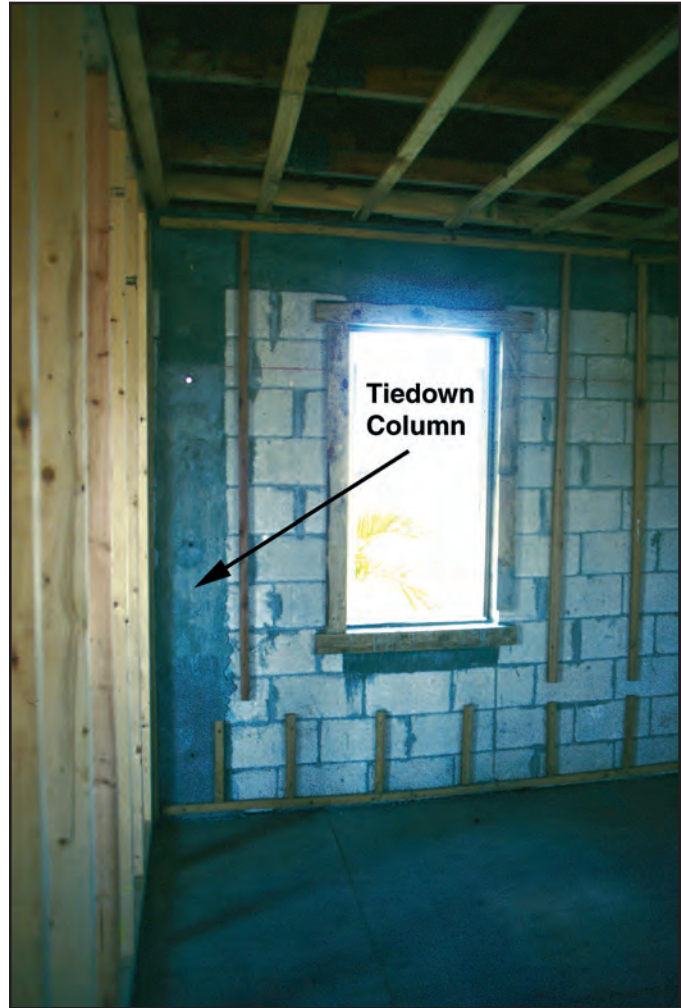
Figure 46
Concrete tiedown columns, such as the one to the left of the window in this photograph, were also used in this house.

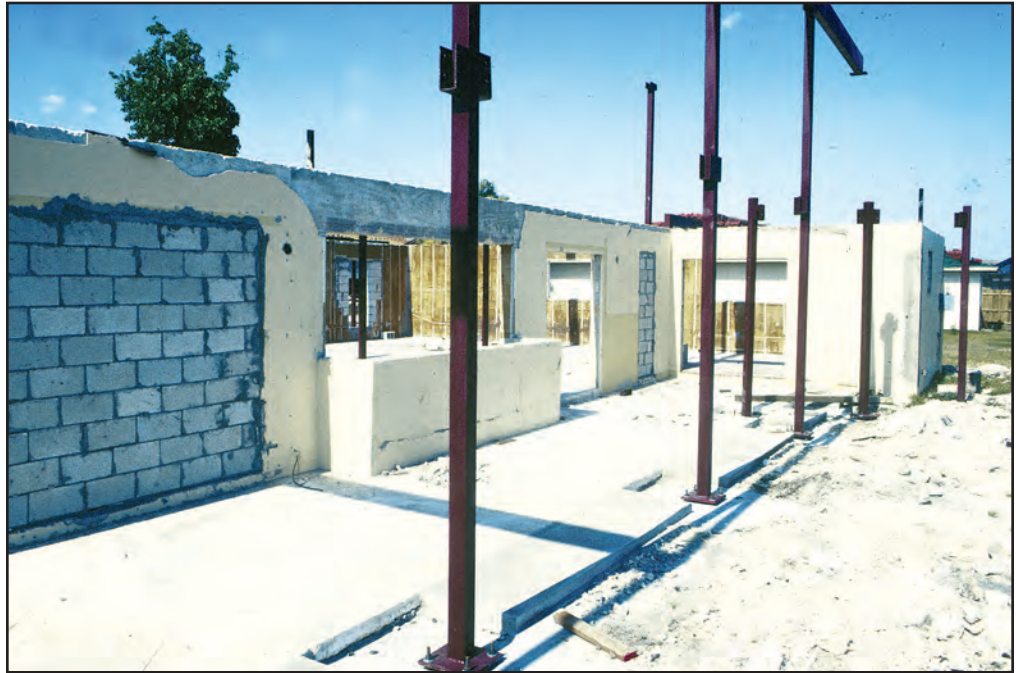
Figure 52

The existing first-story walls have been strengthened by the addition of concrete block. Metal columns and beams have been added to help support the new second story.

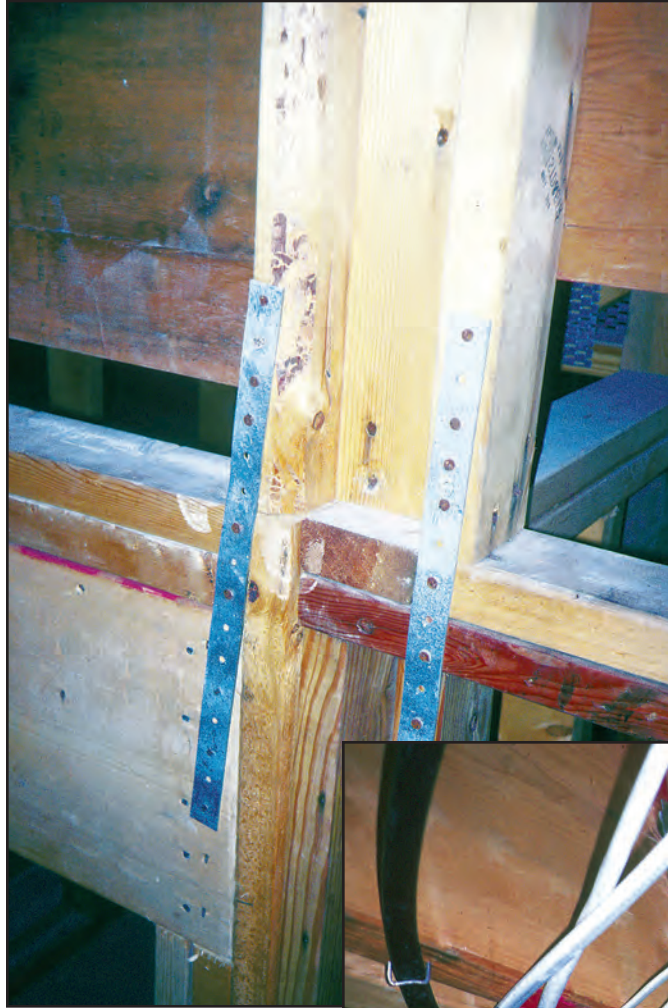
Figure 70

Metal hurricane straps are used to tie the structural members together and create a continuous load path from the roof to the foundation.

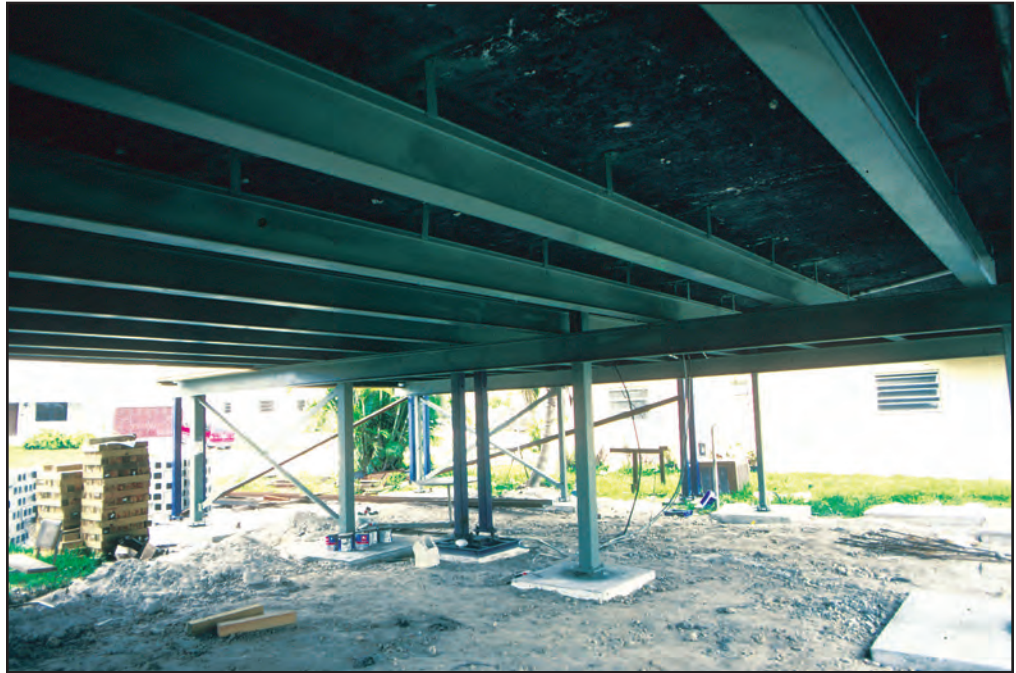
Figure 82
While the jacks and beams supported the house, new steel foundation members were installed below.
