Summary of Lower Platte & Elkhorn Rivers

Initial Ice Report 2/01/2014 through 2/07/2014:

Platte River Ice Thickness measurements- Feb 4, 2014

SUBJECT: Platte River Ice Thickness Measurement Along Union Dike

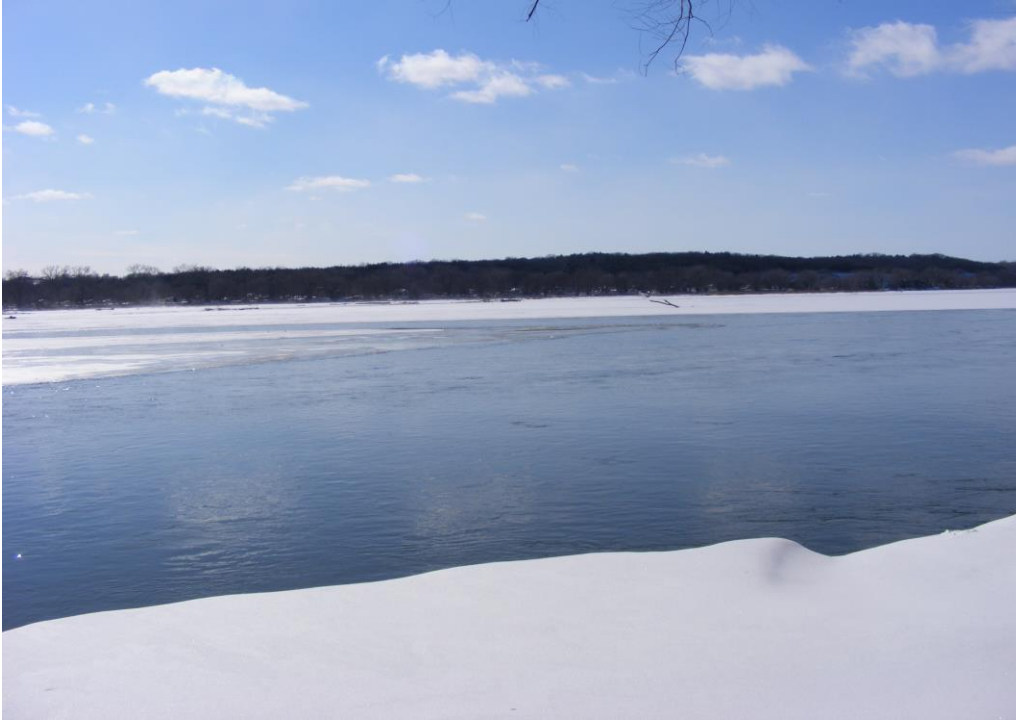
P7 - Sarpy County, on the Platte Hwy 31 at 204 St.

Temperature was 10°F. The average wind speed was 20 mph (N). It was estimated that it was less than feet bank full at this location. The channel remains 65%. It was noted: " 02/05/2014 14:30 Platte River, Hwy 31 Channel depth - 17.78ft Channel flow - 21.7kcfs Flood Stage - 20ft. The channel is ice covered at about 65%. The intact ice surface is snow covered from recent snow on February 3rd & 4th. The channel has about 35% of open water and minimal or no moving ice types."(picture looking across Platte)

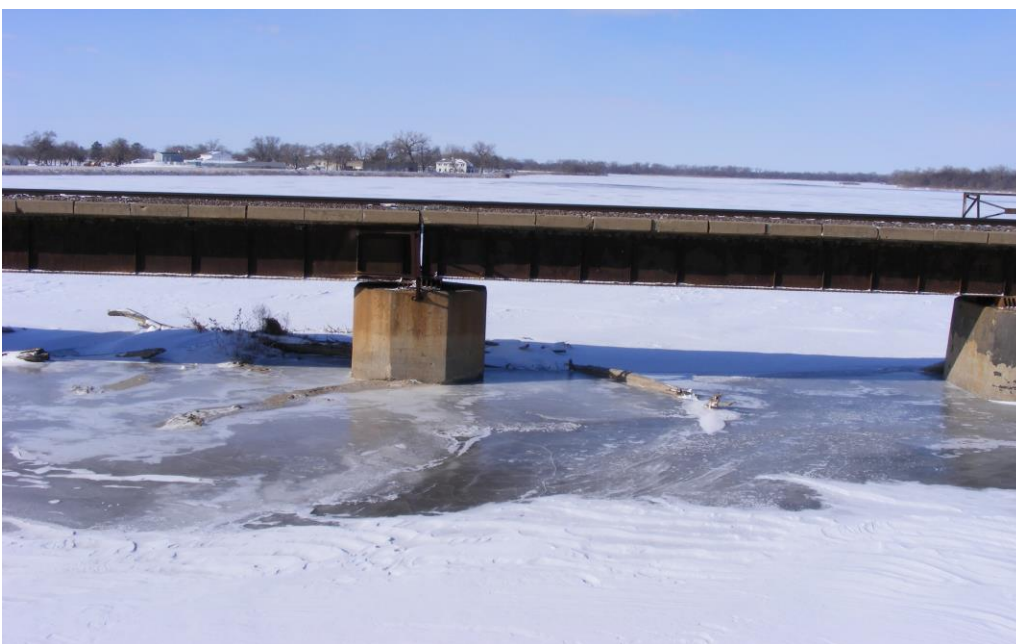
P9 - Sarpy County, on the Platte Hwy 6 & Platte River Bridge (Linoma)

Temperature was 8°F. The average wind speed was 20 mph (N). It was estimated that it was less than feet bank full at this location. The channel remains 5%. It was noted: " 02/05/2014 14:15 Platte River, Ashland Hwy 6 Channel depth - 17.78ft Channel flow - 21.7kcfs Flood Stage - 20ft. The channel is ice covered at about 95%. The intact ice surface is snow covered from recent snow on February 3rd & 4th. The channel has about 5% of open water and no moving ice types."(Picture looking upstream)

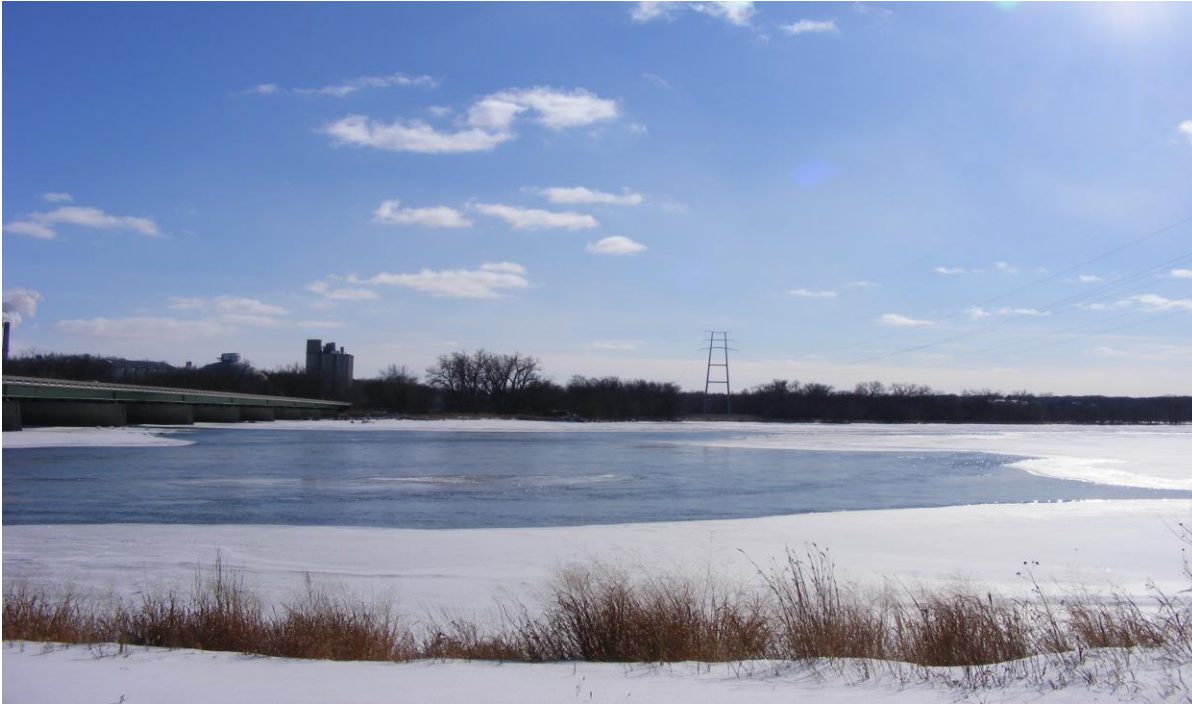
P10 - Sarpy County, on the Platte Hwy 50 & Platte River Bridge

Temperature was 10°F. The average wind speed was 20 mph (N). It was estimated that it was less than feet bank full at this location. The channel remains 75%. It was noted: " 02/05/2014 14:40 Platte River, Hwy 50 Channel depth - 4.21ft Channel flow - 2.54kcfs Flood Stage - 20ft. The channel is ice covered at about 30%. The intact ice surface is snow covered from recent snow on February 3rd & 4th. The channel has about 75% of open water and minimal or no moving ice types. "

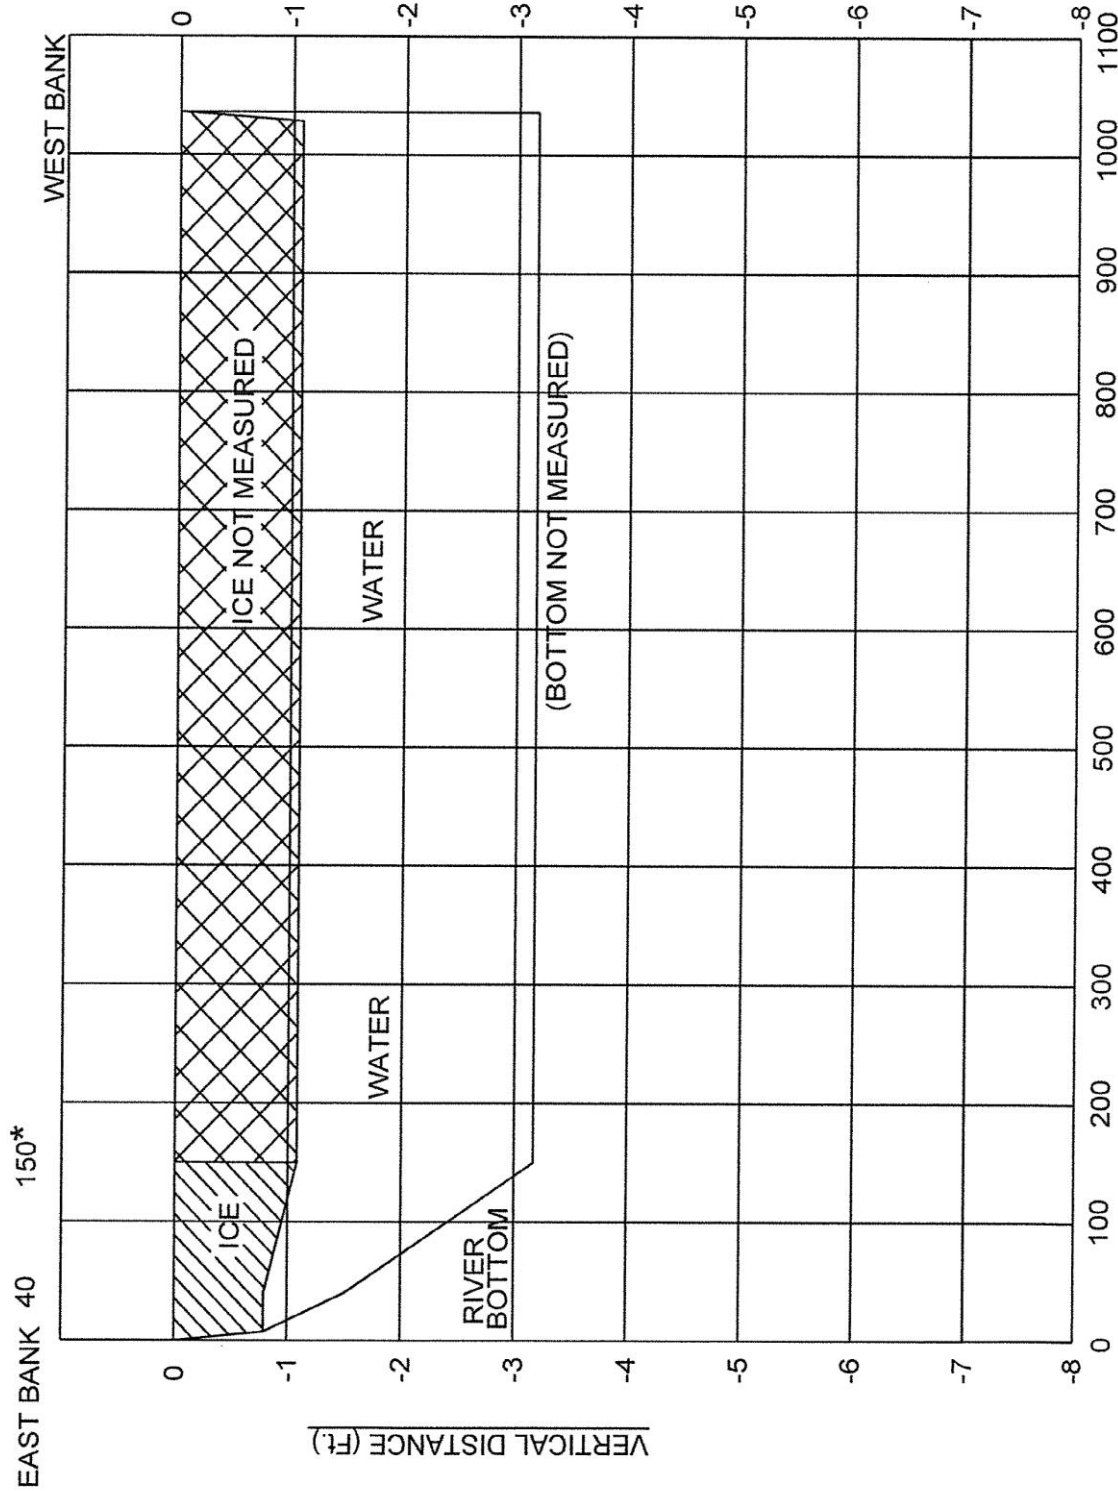
PLATTE RIVER: 1.1 Miles Upstream of Hwy. 64 (STA. 155+00, UNION DIKE)
 (Werner Property)

On February 4, 2014, Pat McEvoy performed ice thickness measurements on the Platte River. The measurements were taken perpendicular to the river flow, near the dike's 10 jetty project location, near Werner Property south line, at approximately Station 155+00 (1.1 miles upstream of Highway 64).

Distance From East Bank (Feet)	Ice Thickness (Inches)	Depth From Top of Ice to River Bed (Inches)
40	9.5	18.0
150*	13.0	38.0

*This hole is located about 850 feet from the west bank of the river. The average ice thickness is **11.3 inches**.

*Hole location is approx. 850' from the west bank.
 February 4th, 2014
