Summary of Lower Platte & Elkhorn Rivers

Ice Report 12/31/2014 through 1/08/2015:

Summary (1/09/2015)

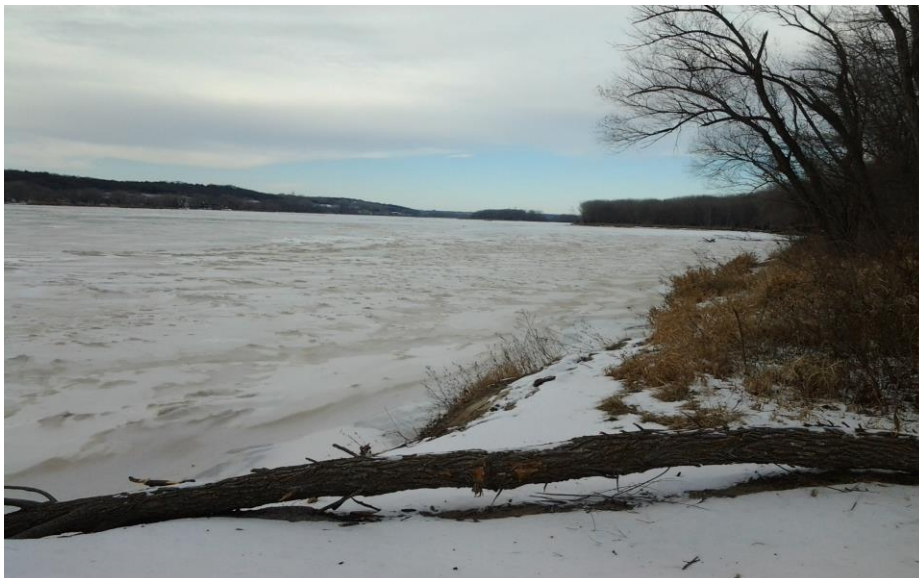
Photo January 8, 2015 -- Platte River at Hwy 31 and 204th St (Station P7)

Temperature was 21°F. The average wind speed was mph (0). It was estimated that it was less than feet bank full at this location. The channel remains 100%. It was noted: "P7 2015-01-08 11.08.22 Platte River, Schram Park Hwy 31 Channel depth - 5.72ft Channel flow - 21.8kcfs Flood Stage - 9ft. Water temp ° the channel is 0% open." Photo # 11.08.22

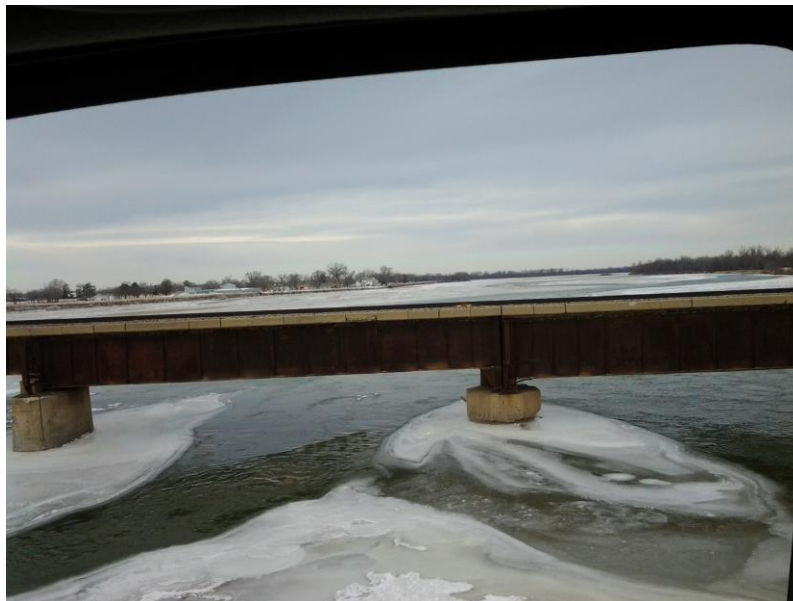
Photo on 8 January 2015 at the Hwy 6 Bridge by Ashland. (Station P9)

Temperature was 19°F. The average wind speed was 20 mph (SW). It was estimated that it was less than feet bank full at this location. The channel remains 10%. It was noted: " P9 12/31/2014 14:56 Platte River, Ashland Hwy 6 Channel depth - 16.32ft Channel flow – 8.12kcfs Flood Stage - 20ft. The channel is 95% open with floating frazil slush. Photo ID 2015-01-08 10.38.14 "

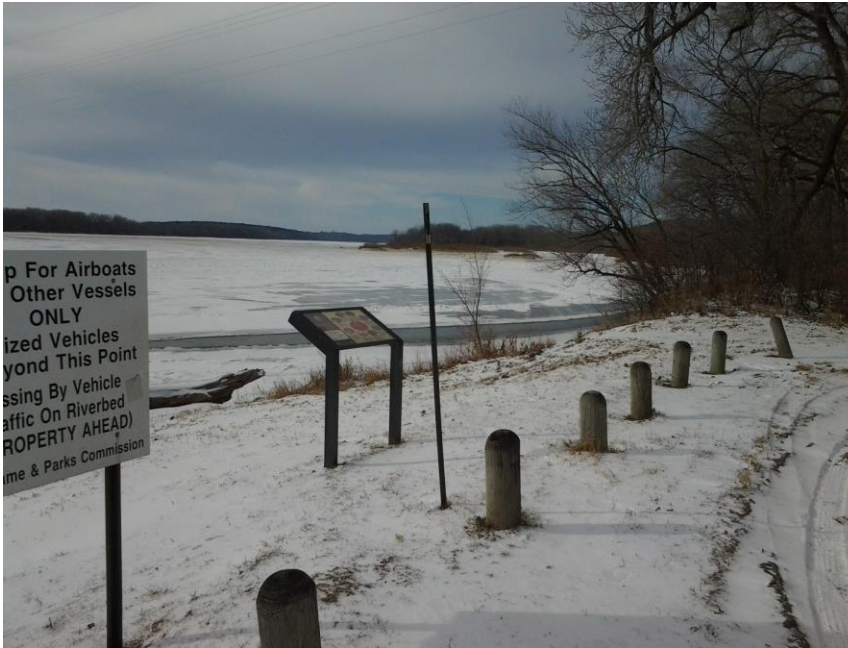
January 8, 2015-- Hwy 50 and Platte River Bridge (P10 Station)

Temperature was 22°F. The average wind speed was 15 mph (SW). It was estimated that it was less than feet bank full at this location. The channel remains <1%. It was noted: "P10 2015-01-08 11.19.26 Platte River, Hwy 50 Channel depth – 5.72ft. Channel flow – 12.2kcfs Flood Stage - 9ft. Water temp ° The channel is <1% open." Photo # 11.19.26
