Summary of Lower Platte & Elkhorn Rivers

Ice Report 1/16/2015 through 1/22/2015:

Summary (1/23/2015)

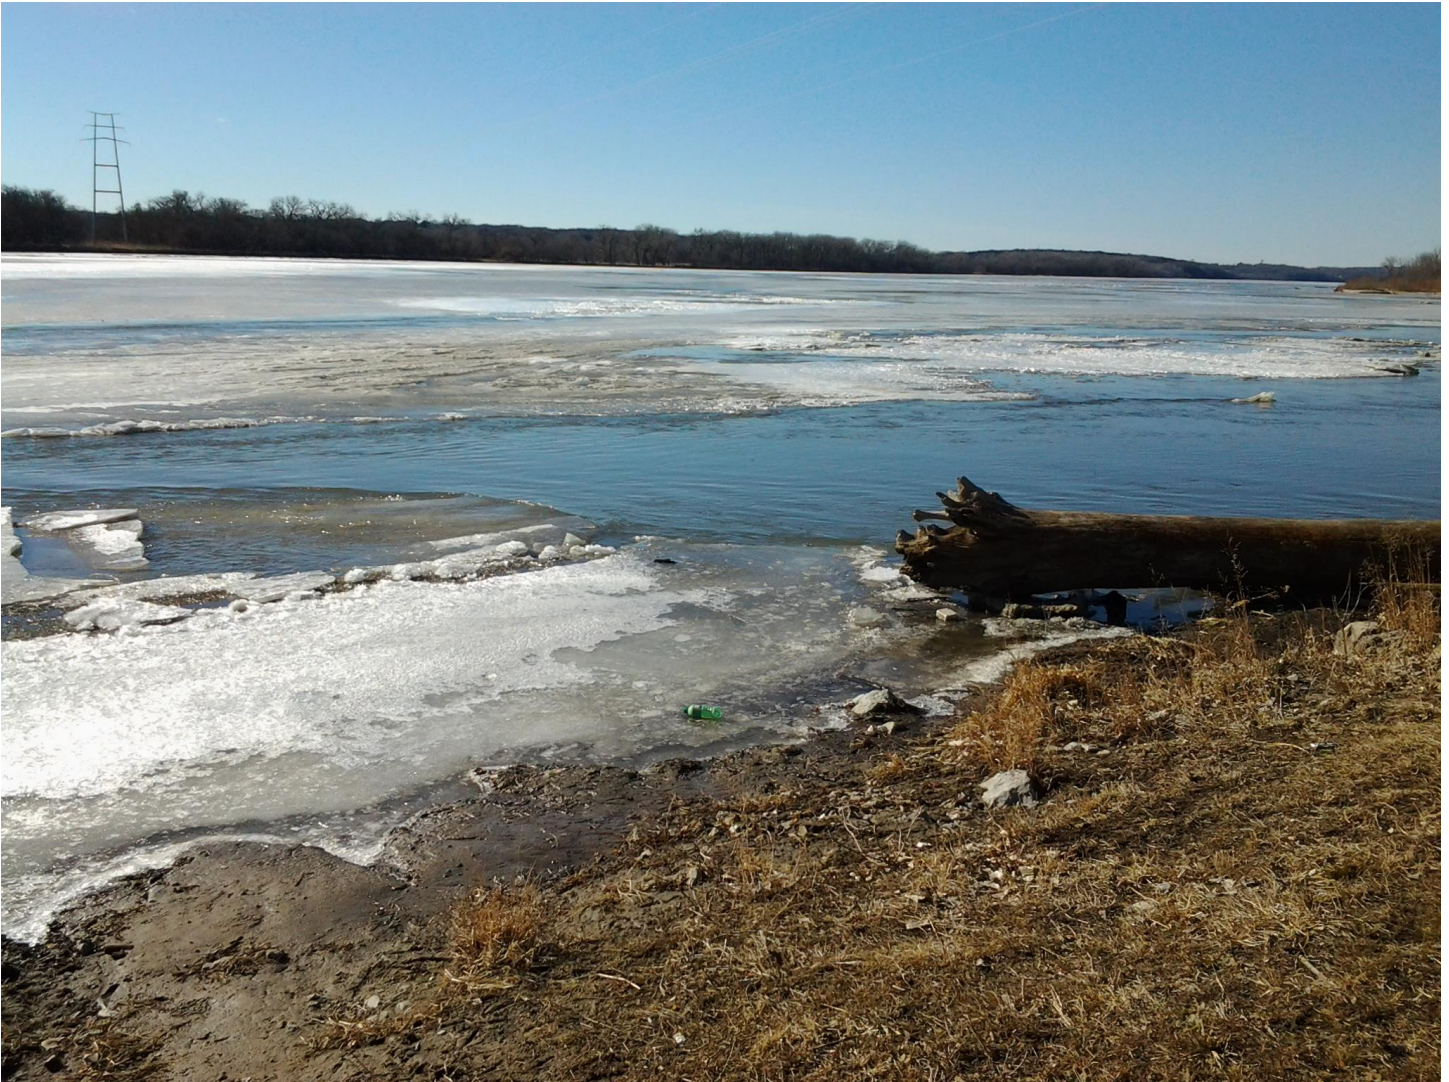
Site Station P10 (Photo # 11.20.14) Platte River –Hwy 50

Temperature was 44°F. The average wind speed was 10 mph (W). It was estimated that it was less than 3.28 feet bank full at this location. The channel remains 5%. It was noted: "Conditions have changed from mostly freeze up to open channels. The warm temps of 40s and 50s over the past week and going into next week should drastically reduce ice amounts."
