Summary of Lower Platte & Elkhorn Rivers

Ice Report 1/23/2015 through 1/29/2015:

Summary (1/30/2015)

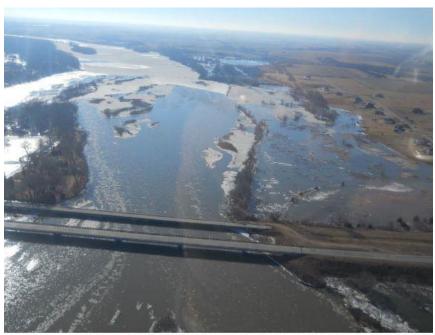
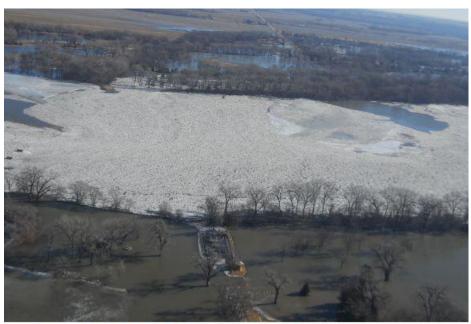
PM4 - Douglas County, on the Platte Hwy 92

An <u>ICE JAM</u> approximately 1.5 miles in length formed Monday night into Tuesday morning on the <u>Platte River</u>. Authorities declared an emergency and prepared to blast the jam due to flooding and potential threats to well fields and other properties. The plan to use explosives was cancelled on Thursday morning after nature intervened and the jam broke open on its own. For the other areas of the <u>Platte River</u>, <u>Elkhorn River and the Confluence of the Platte and Elkhorn Rivers</u> were experiencing 50 to 100% open channels. Colder temperatures are expected for the next several days so more freezing is expected.

Temperature was 34°F. The average wind speed was 10 mph (NW). It was estimated that it was less than 9 feet bank full at this location. The channel remains 100%. It was noted: "West channel of Platte is 100% open, East side is 100% frozen. Half mile downstream of the Highway 92 Bridge is an ice jam that is about 1 1/2 mile long. The ice jam extends from F Street to Q Street."

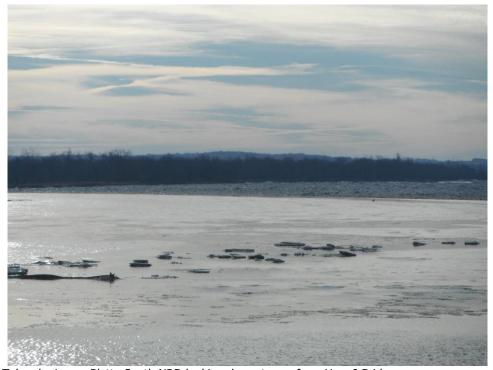
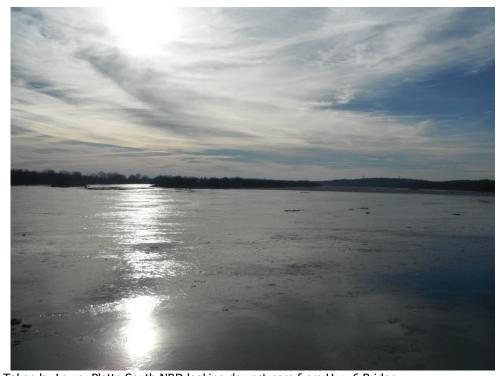
LS 1 – Saunders County, on the Platte Hwy 6 near Ashland

Temperature was 38°F. The average wind speed was 9 mph (SE). It was estimated that it was less than feet bank full at this location. The channel remains NA%. It was noted: "Upstream of bridge 90% open. Downstream of the bridge right channel jammed, flow being deflected to left side of island."

Taken by Lower Platte South NRD looking downstream from Hwy 6 Bridge
