Summary of Lower Platte & Elkhorn Rivers

Initial Ice Report 12/21/2016 through 12/30/2016:

Summary (12/30/2016)

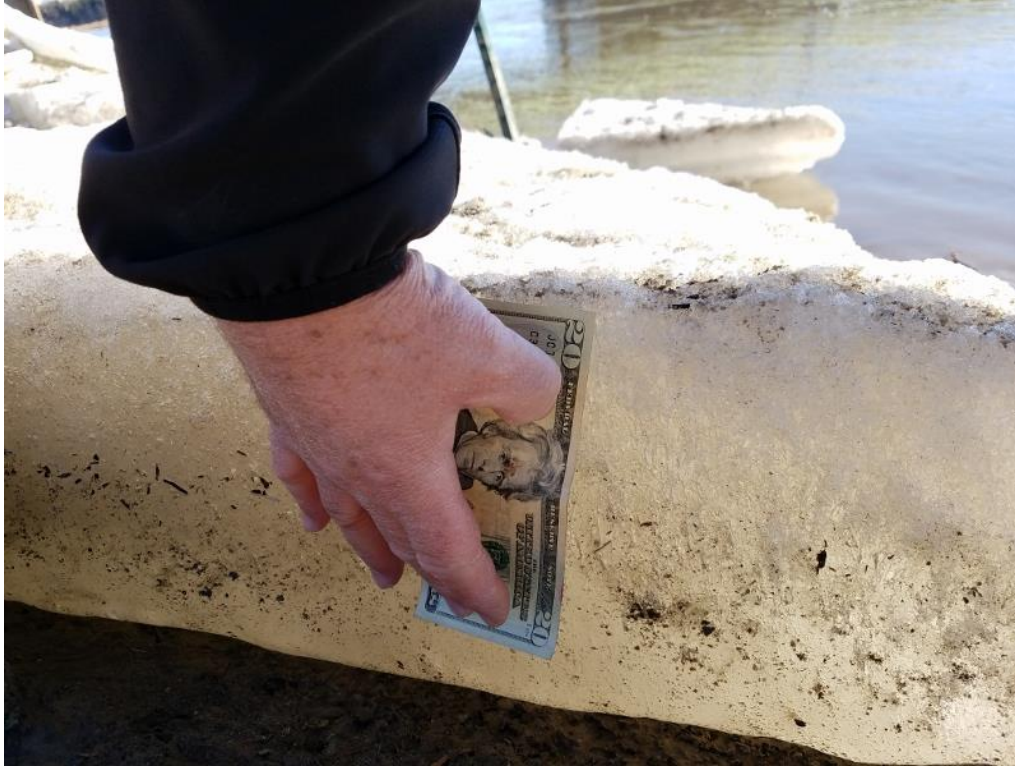
After the break-up earlier this week in Sarpy County. (Lynn Marshall)

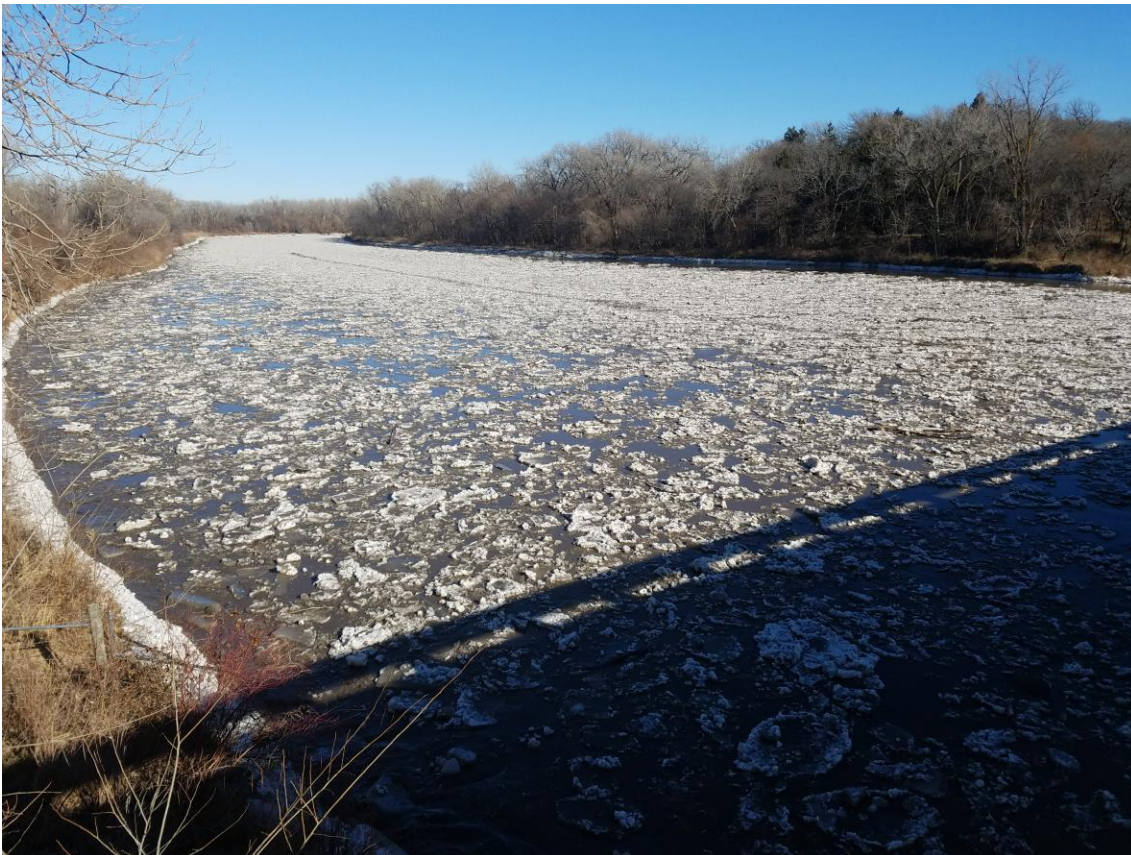
Confluence of the Platte and Elkhorn Rivers:**E1 - Sarpy County, on the Platte/Elkhorn Confluence of Platte and Elkhorn Rivers****Elkhorn River:****PM2 - Douglas County, on the Elkhorn Hwy 36****PM3 - Douglas/Saunders County, on the Elkhorn Hwy 92****PM6 - Douglas County, on the Elkhorn Hwy 64****Loup River:****NR1 - Loup County, on the Loup Hwy 281 at St. Paul****12/26/2016 Elkhorn River following warm weather break up**
