Summary of Lower Platte & Elkhorn Rivers

Initial Ice Report 1/14/2018 through 1/19/2018:

Ice Thickness Summary (1/18/2018)

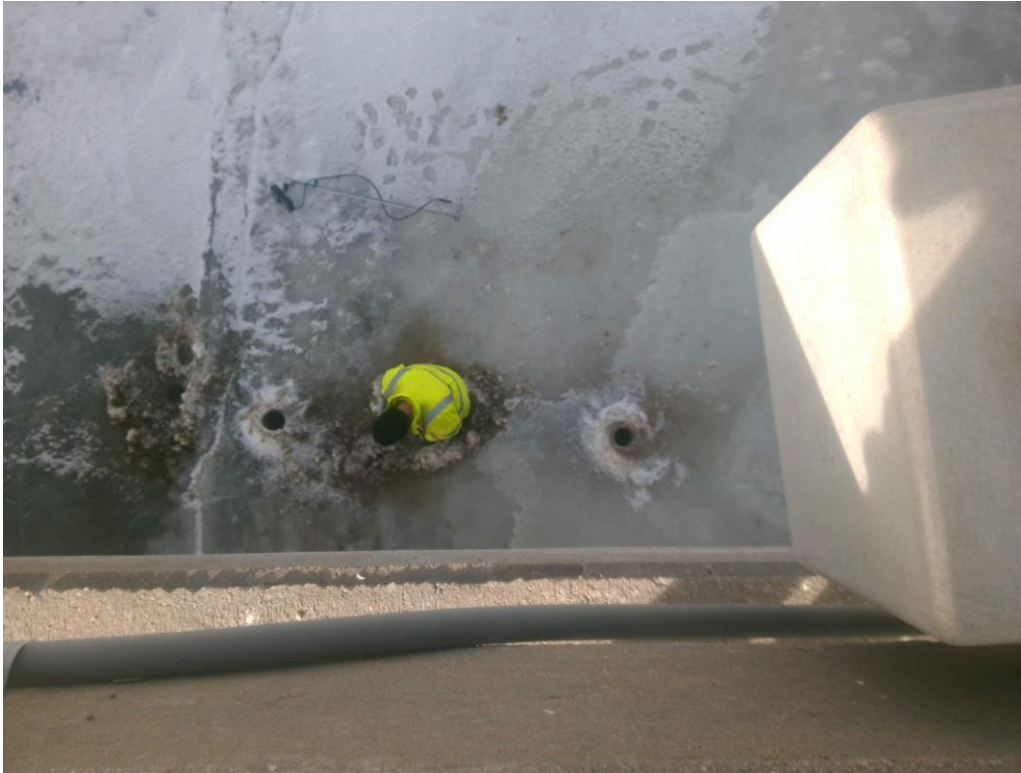
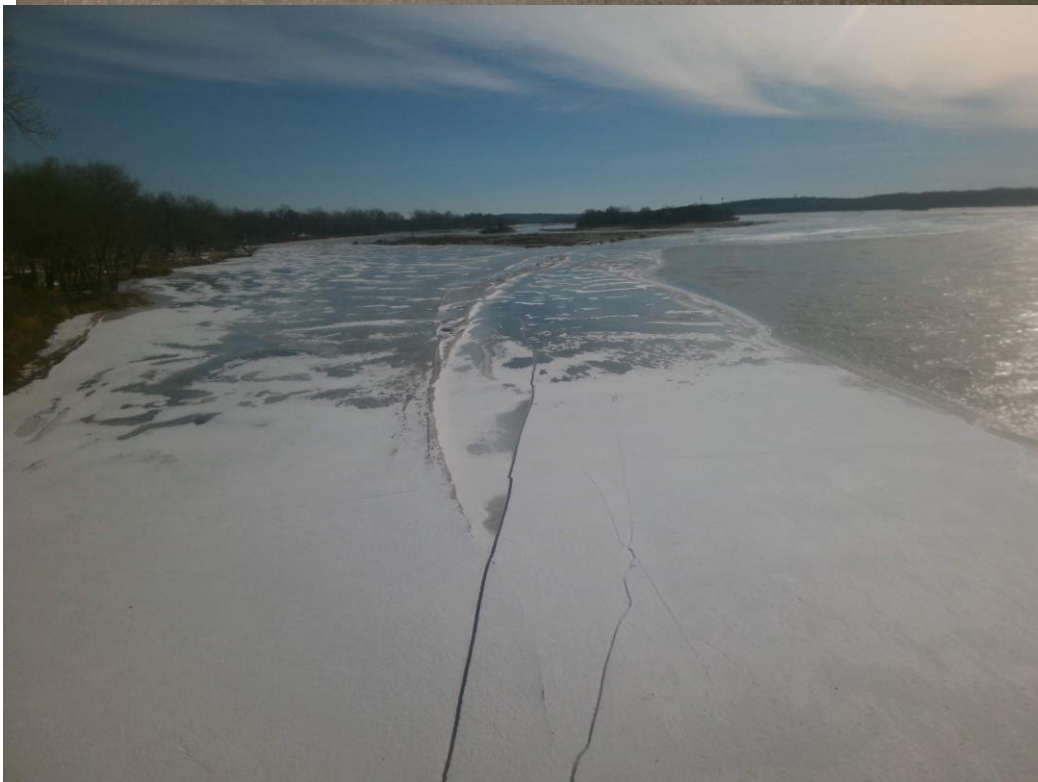
USGS had crews out Thursday Jan 18th doing measurements on both rivers. Below are two shots from Hwy 6 Bridge - Linoma Beach.

Ice thickness at the Platte near Ashland Gage was on average one foot thick with up to 2.5 feet in some places. Platte River at Leshara was 1.00 to 1.5 feet and Elkhorn River at Waterloo was just over a foot on average. (1-18-2018)

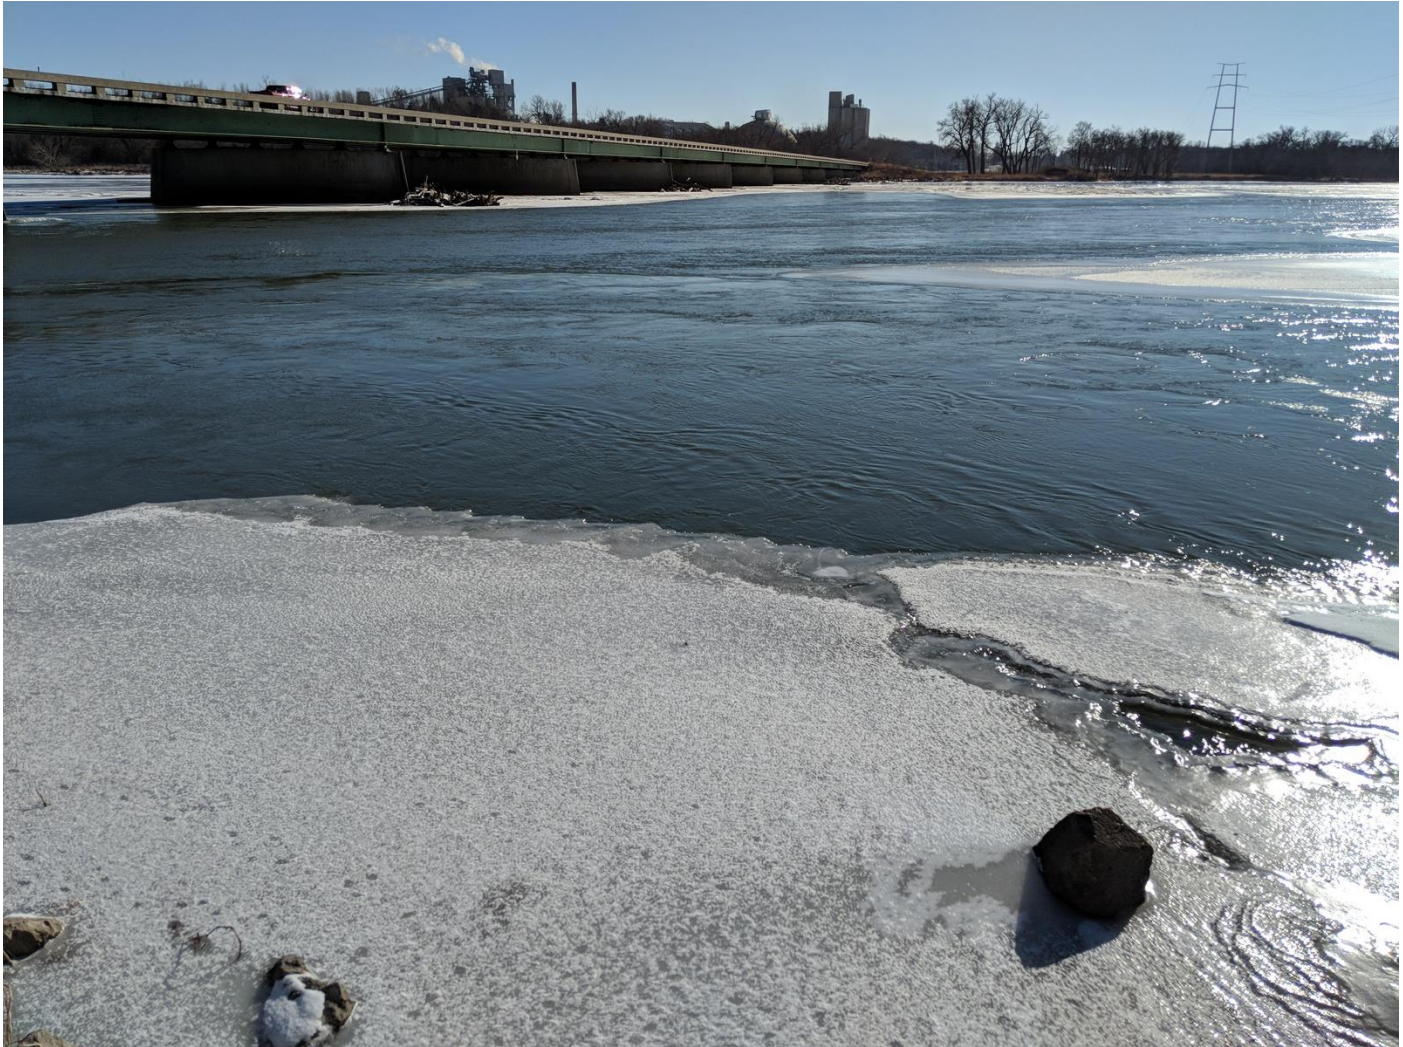
P10 - Sarpy County, on the Platte Hwy 50 & Platte River Bridge

Temperature was 29°F. The average wind speed was 7 mph (S). It was estimated that it was less than 3 feet bank full at this location. The channel remains 65%. It was noted: " " (Photo Jesse Eret, Sarpy Co Ems on Jan 17 2018)
