## Summary of Lower Platte & Elkhorn Rivers

### Initial Ice Report 1/27/2018 through 2/2/2018:

## Memorandum

**To:** File 536, 528  
**From:** Bill Warren, O&M Superintendent  
**Date:** February 1, 2018  
**Re:** Platte River Ice Thickness Measurement Along Union Dike

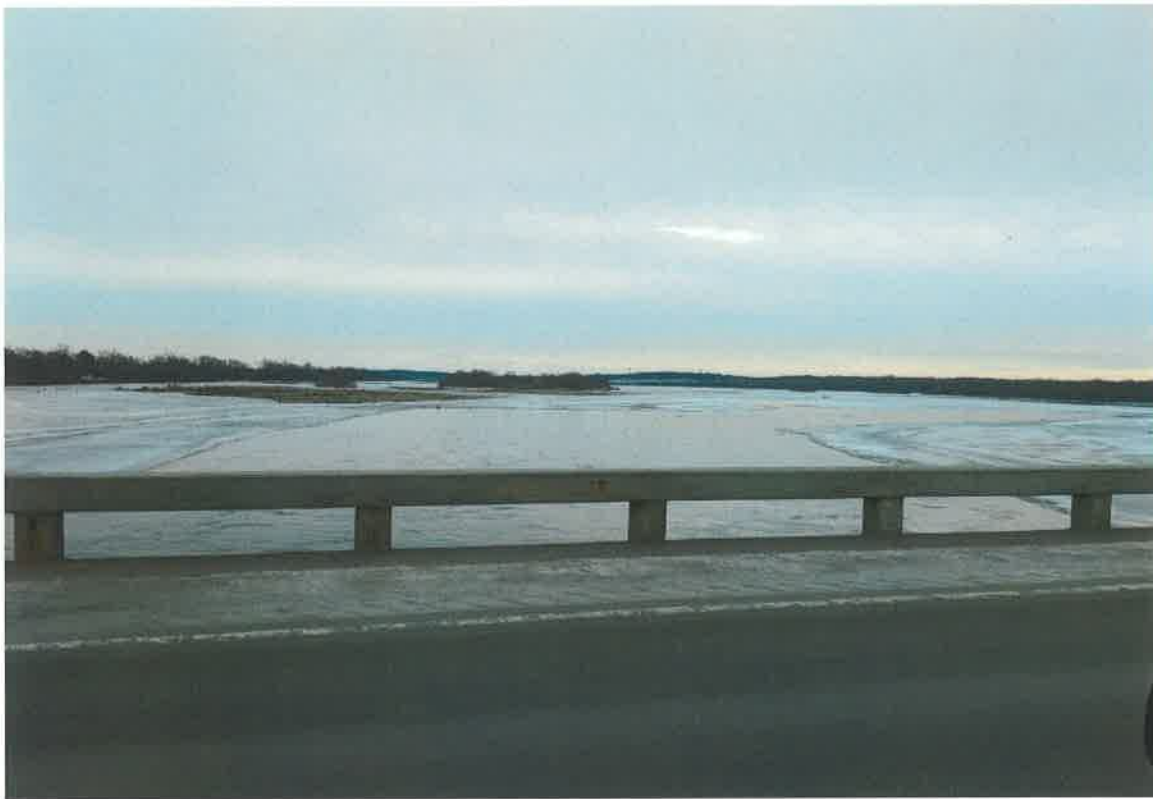
P9 - Sarpy County, on the Platte Hwy 6 & Platte River Bridge (Linoma)

Temperature was 39.5°F. The average wind speed was 3 mph (NW). It was estimated that it was less than 3 feet bank full at this location. The channel remains 30%. It was noted: " (Following Picture by Jesse Eret, Sarpy Co EMA)

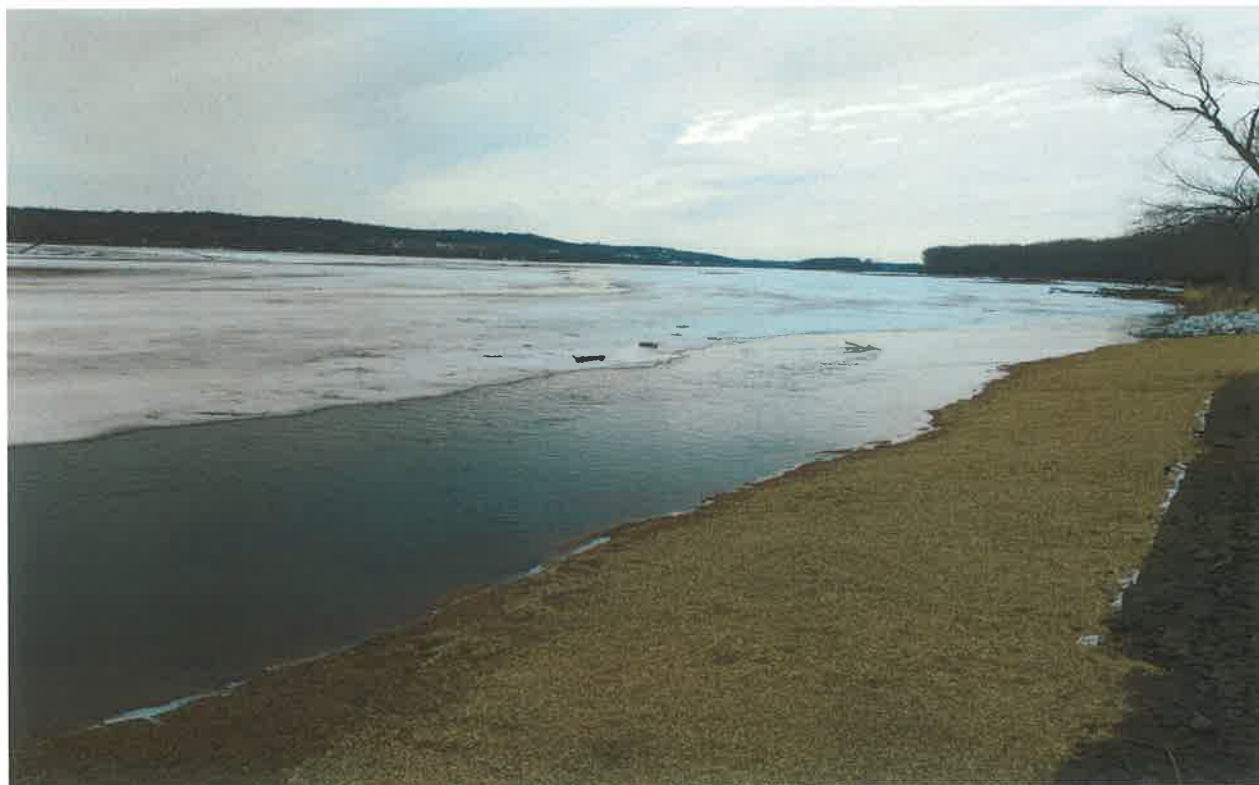
P7 - Sarpy County, on the Platte Hwy 31 at 204 St.

Temperature was 40°F. The average wind speed was 4 mph (SW). It was estimated that it was less than 3 feet bank full at this location. The channel remains 10%. It was noted: " (Following Picture by Jesse Eret, Sarpy Co EMA)

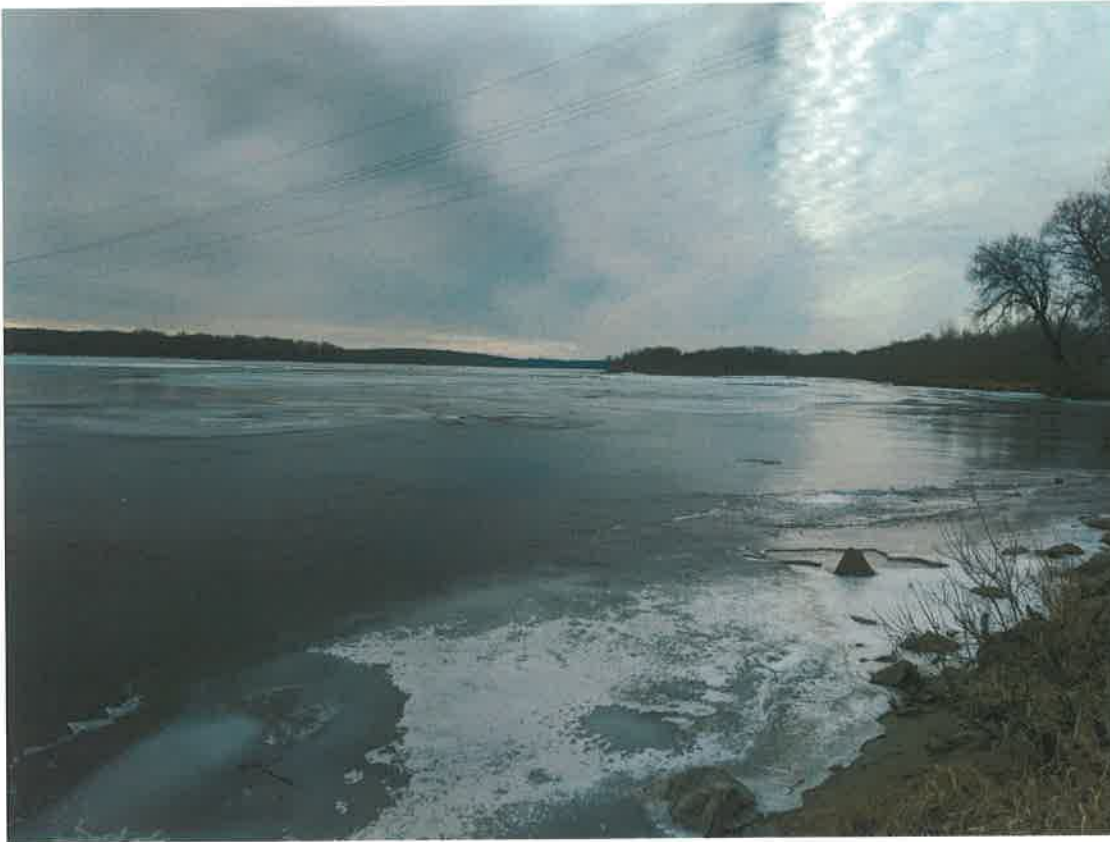
P10 - Sarpy County, on the Platte Hwy 50 & Platte River Bridge

Temperature was 40.5°F. The average wind speed was 2 mph (SE). It was estimated that it was less than 3 feet bank full at this location. The channel remains 80%. It was noted" (Following Picture by Jesse Eret, Sarpy Co EMA)

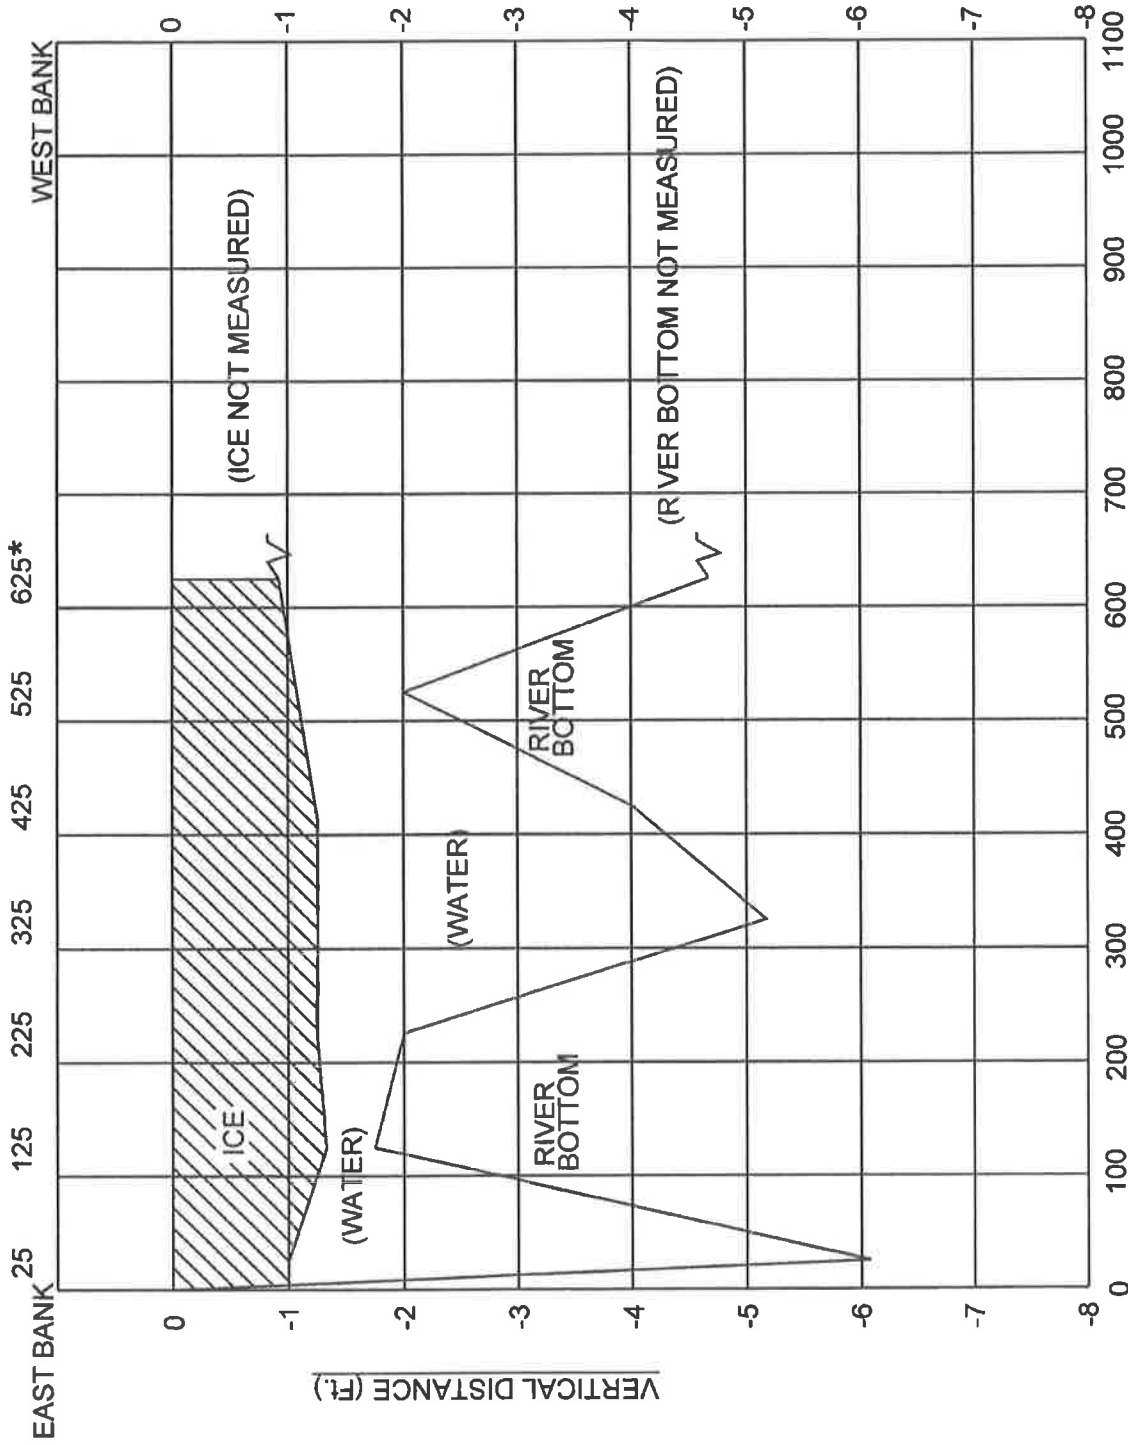
**PLATTE RIVER: 1.1 Miles Upstream of Hwy. 64 (STA. 155+00, UNION DIKE)**  
**(Werner Property)**

Distance From East Bank (Feet)	Ice Thickness (Inches)	Depth From Top Of Ice To River Bed (Inches)
25	12	73
125	16	21
225	15	24
325	15	62
425	13	48
525	13	24
625	11	56

\*The entire river has an ice cover, but only the 0 to 625 ft. width of ice from the east bank of the river is considered safe enough to conduct borings. The west bank is approximately 400 feet west of 625 ft. boring.

The average ice thickness is **13.6 inches**.

\*Hole location is approx. 400' from the west bank.  
 February 1st, 2018
