Summary of Lower Platte & Elkhorn Rivers

Initial Ice Report 1/20/2018 through 1/26/2018:

Re: Platte River Ice Thickness Measurement Along Union Dike

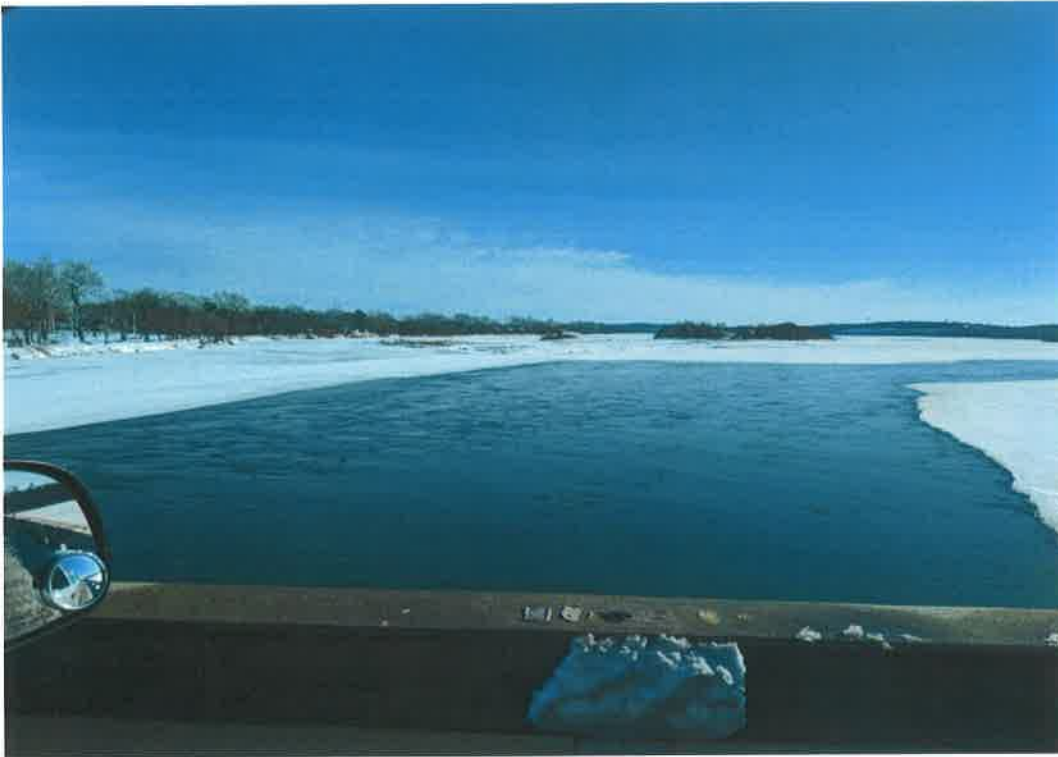
P9 - Sarpy County, on the Platte Hwy 6 & Platte River Bridge (Linoma)

Temperature was 41°F. The average wind speed was 5.8 mph (SE). It was estimated that it was less than 3 feet bank full at this location. The channel remains 25%. It was noted: " (Following picture by Jesse Eret, Sarpy Co EMA)

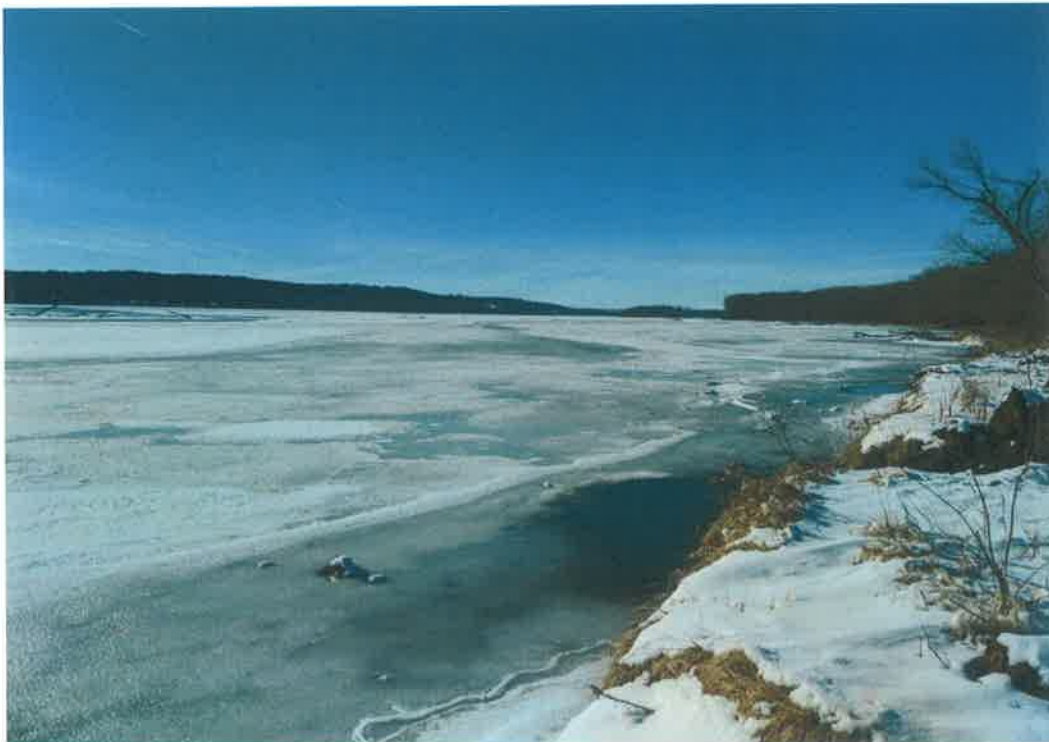
P7 - Sarpy County, on the Platte Hwy 31 at 204 St.

Temperature was 43.2°F. The average wind speed was 5 mph (SW). It was estimated that it was less than 2 feet bank full at this location. The channel remains 10%. It was noted: " (Following Picture by Jesse Eret, Sarpy Co EMA)

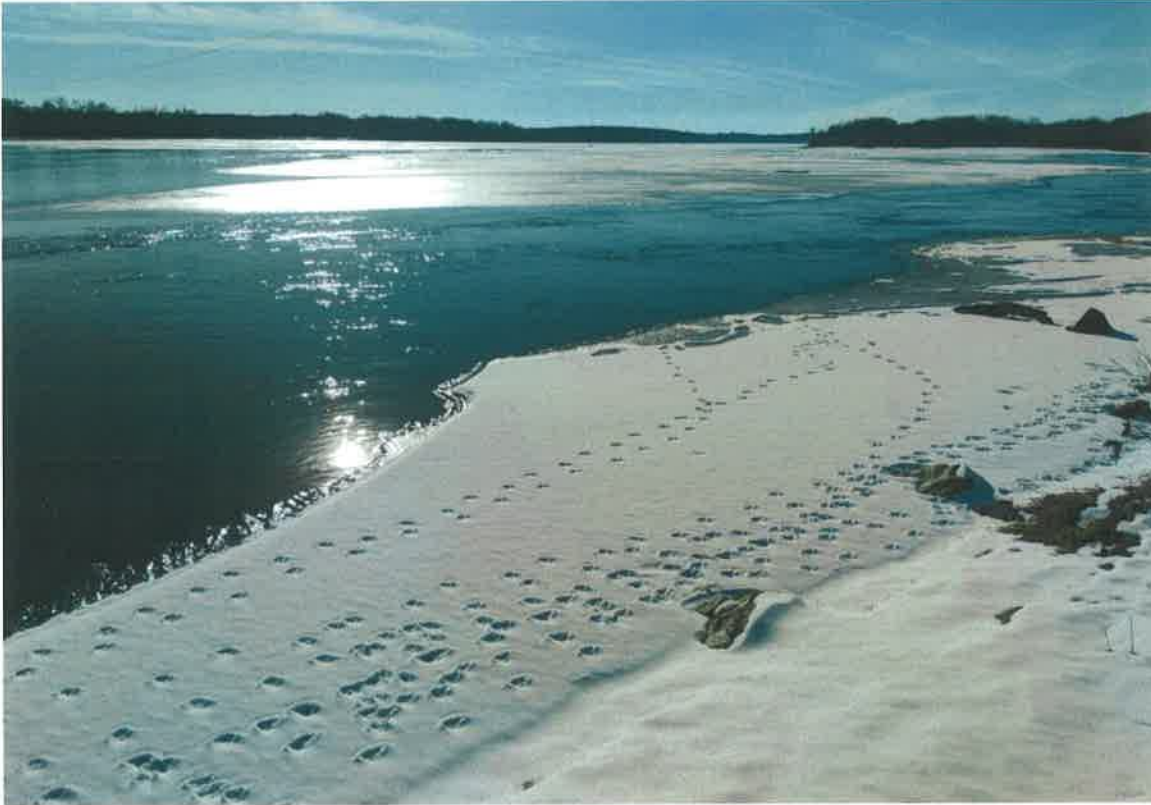
P10 - Sarpy County, on the Platte Hwy 50 & Platte River Bridge

Temperature was 42.7°F. The average wind speed was 5 mph (SW). It was estimated that it was less than 1 feet bank full at this location. The channel remains 90%. It was noted: " (Following Picture by Jesse Eret, Sarpy Co EMA)

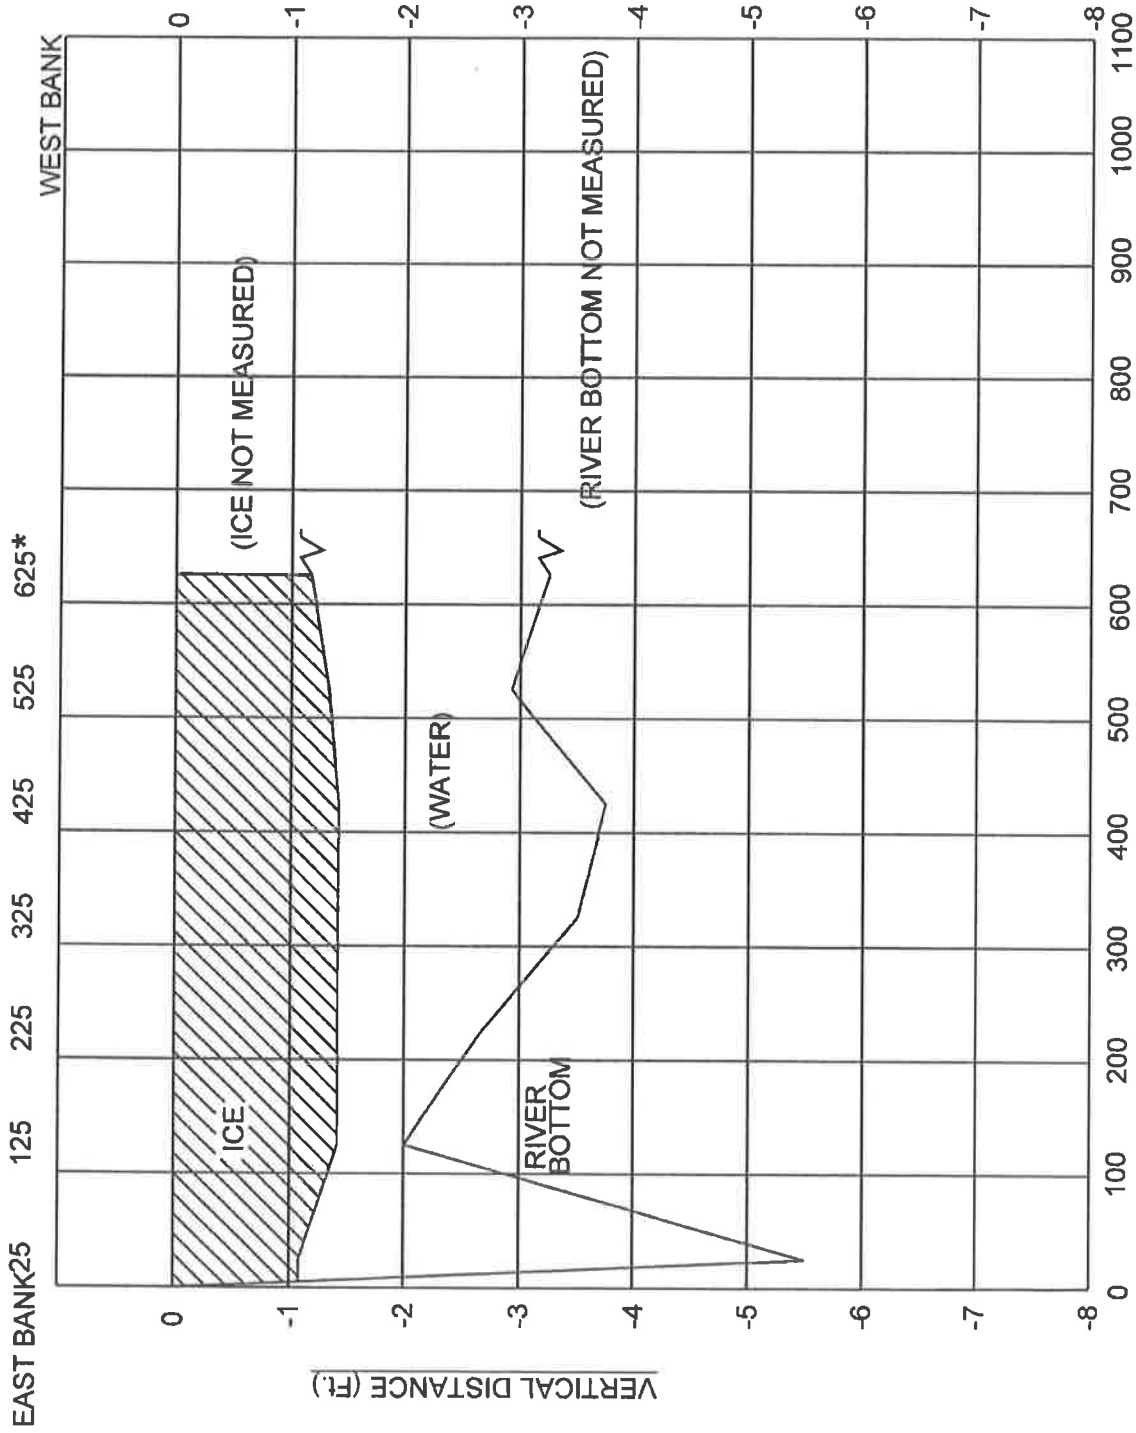
PLATTE RIVER: 1.1 Miles Upstream of Hwy. 64 (STA. 155+00, UNION DIKE)
(Werner Property)

Distance From East Bank (Feet)	Ice Thickness (Inches)	Depth From Top Of Ice To River Bed (Inches)
25	13	66
125	17	24
225	17	32
325	17	42
425	15	45
525	14	35
625	13	39

*The entire river has an ice cover, but only the 0 to 625 ft. width of ice from the east bank of the river is considered safe enough to conduct borings. The west bank is approximately 400 feet west of 625 ft. boring.

The average ice thickness is **15.1 Inches**.

*Hole location is approx. 400' from the west bank.
 January 25th, 2018
