## Summary of Lower Platte & Elkhorn Rivers

# <u> Initial Ice Report 1/26/2022 through 2/4/2022:</u>

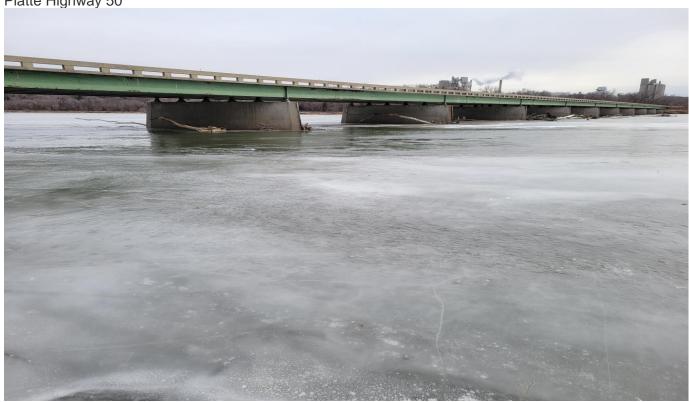
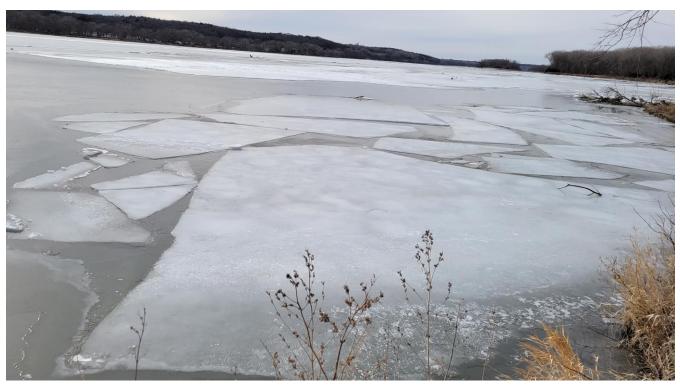
Temperature was 10°F. The average wind speed was 14 mph (N). It is estimated that less than N/A feet bank full at this location. It was noted:" The west channel has an open channel along the west bank, approximately 20 ft wide with no moving ice. There is an channel downstream of the bridge extending approximately 500 upstream. The east channel is 100% ice covered."
