## Summary of Lower Platte & Elkhorn Rivers

### Initial Ice Report 1/7/2017 through 1/13/2017:

#### Summary (1/13/2017)

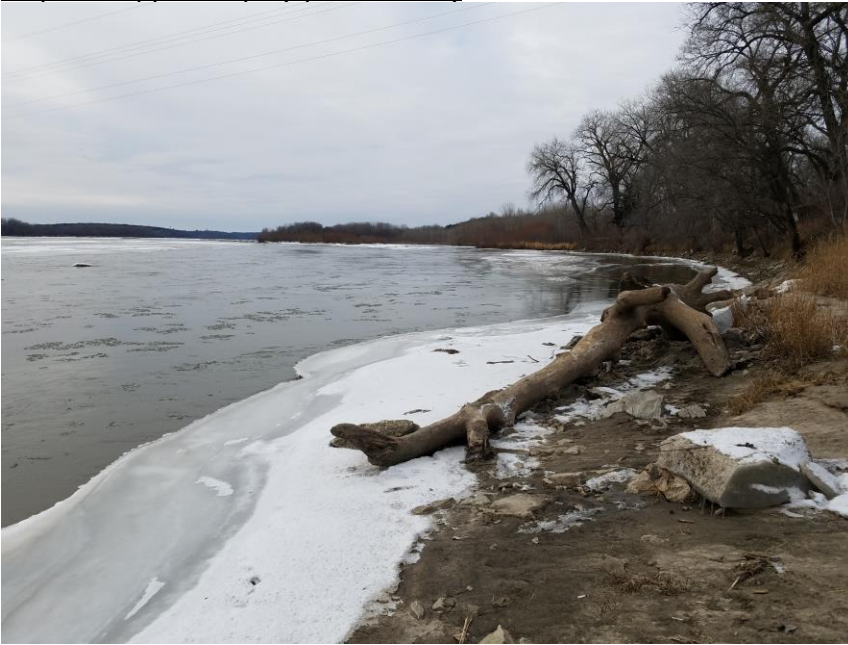
Hwy 50 Sarpy County. (Lynn Marshall)

Temperature was 22°F. The average wind speed was 10 mph (N). It was estimated that it was less than 4.60 feet bank full at this location. The channel remains 90%. It was noted: "Plate River channel is 90% clear with less than 5% frazil and frazil pans floating. Current stage and flow 3.40ft 5.57kcfs"
